FORMER TELSTRA CORPORATION DEPOT  
BRITANNIA STREET, GEELONG WEST

## ENVIRONMENTAL AUDIT REPORT

July 1997

Ref. No.100842

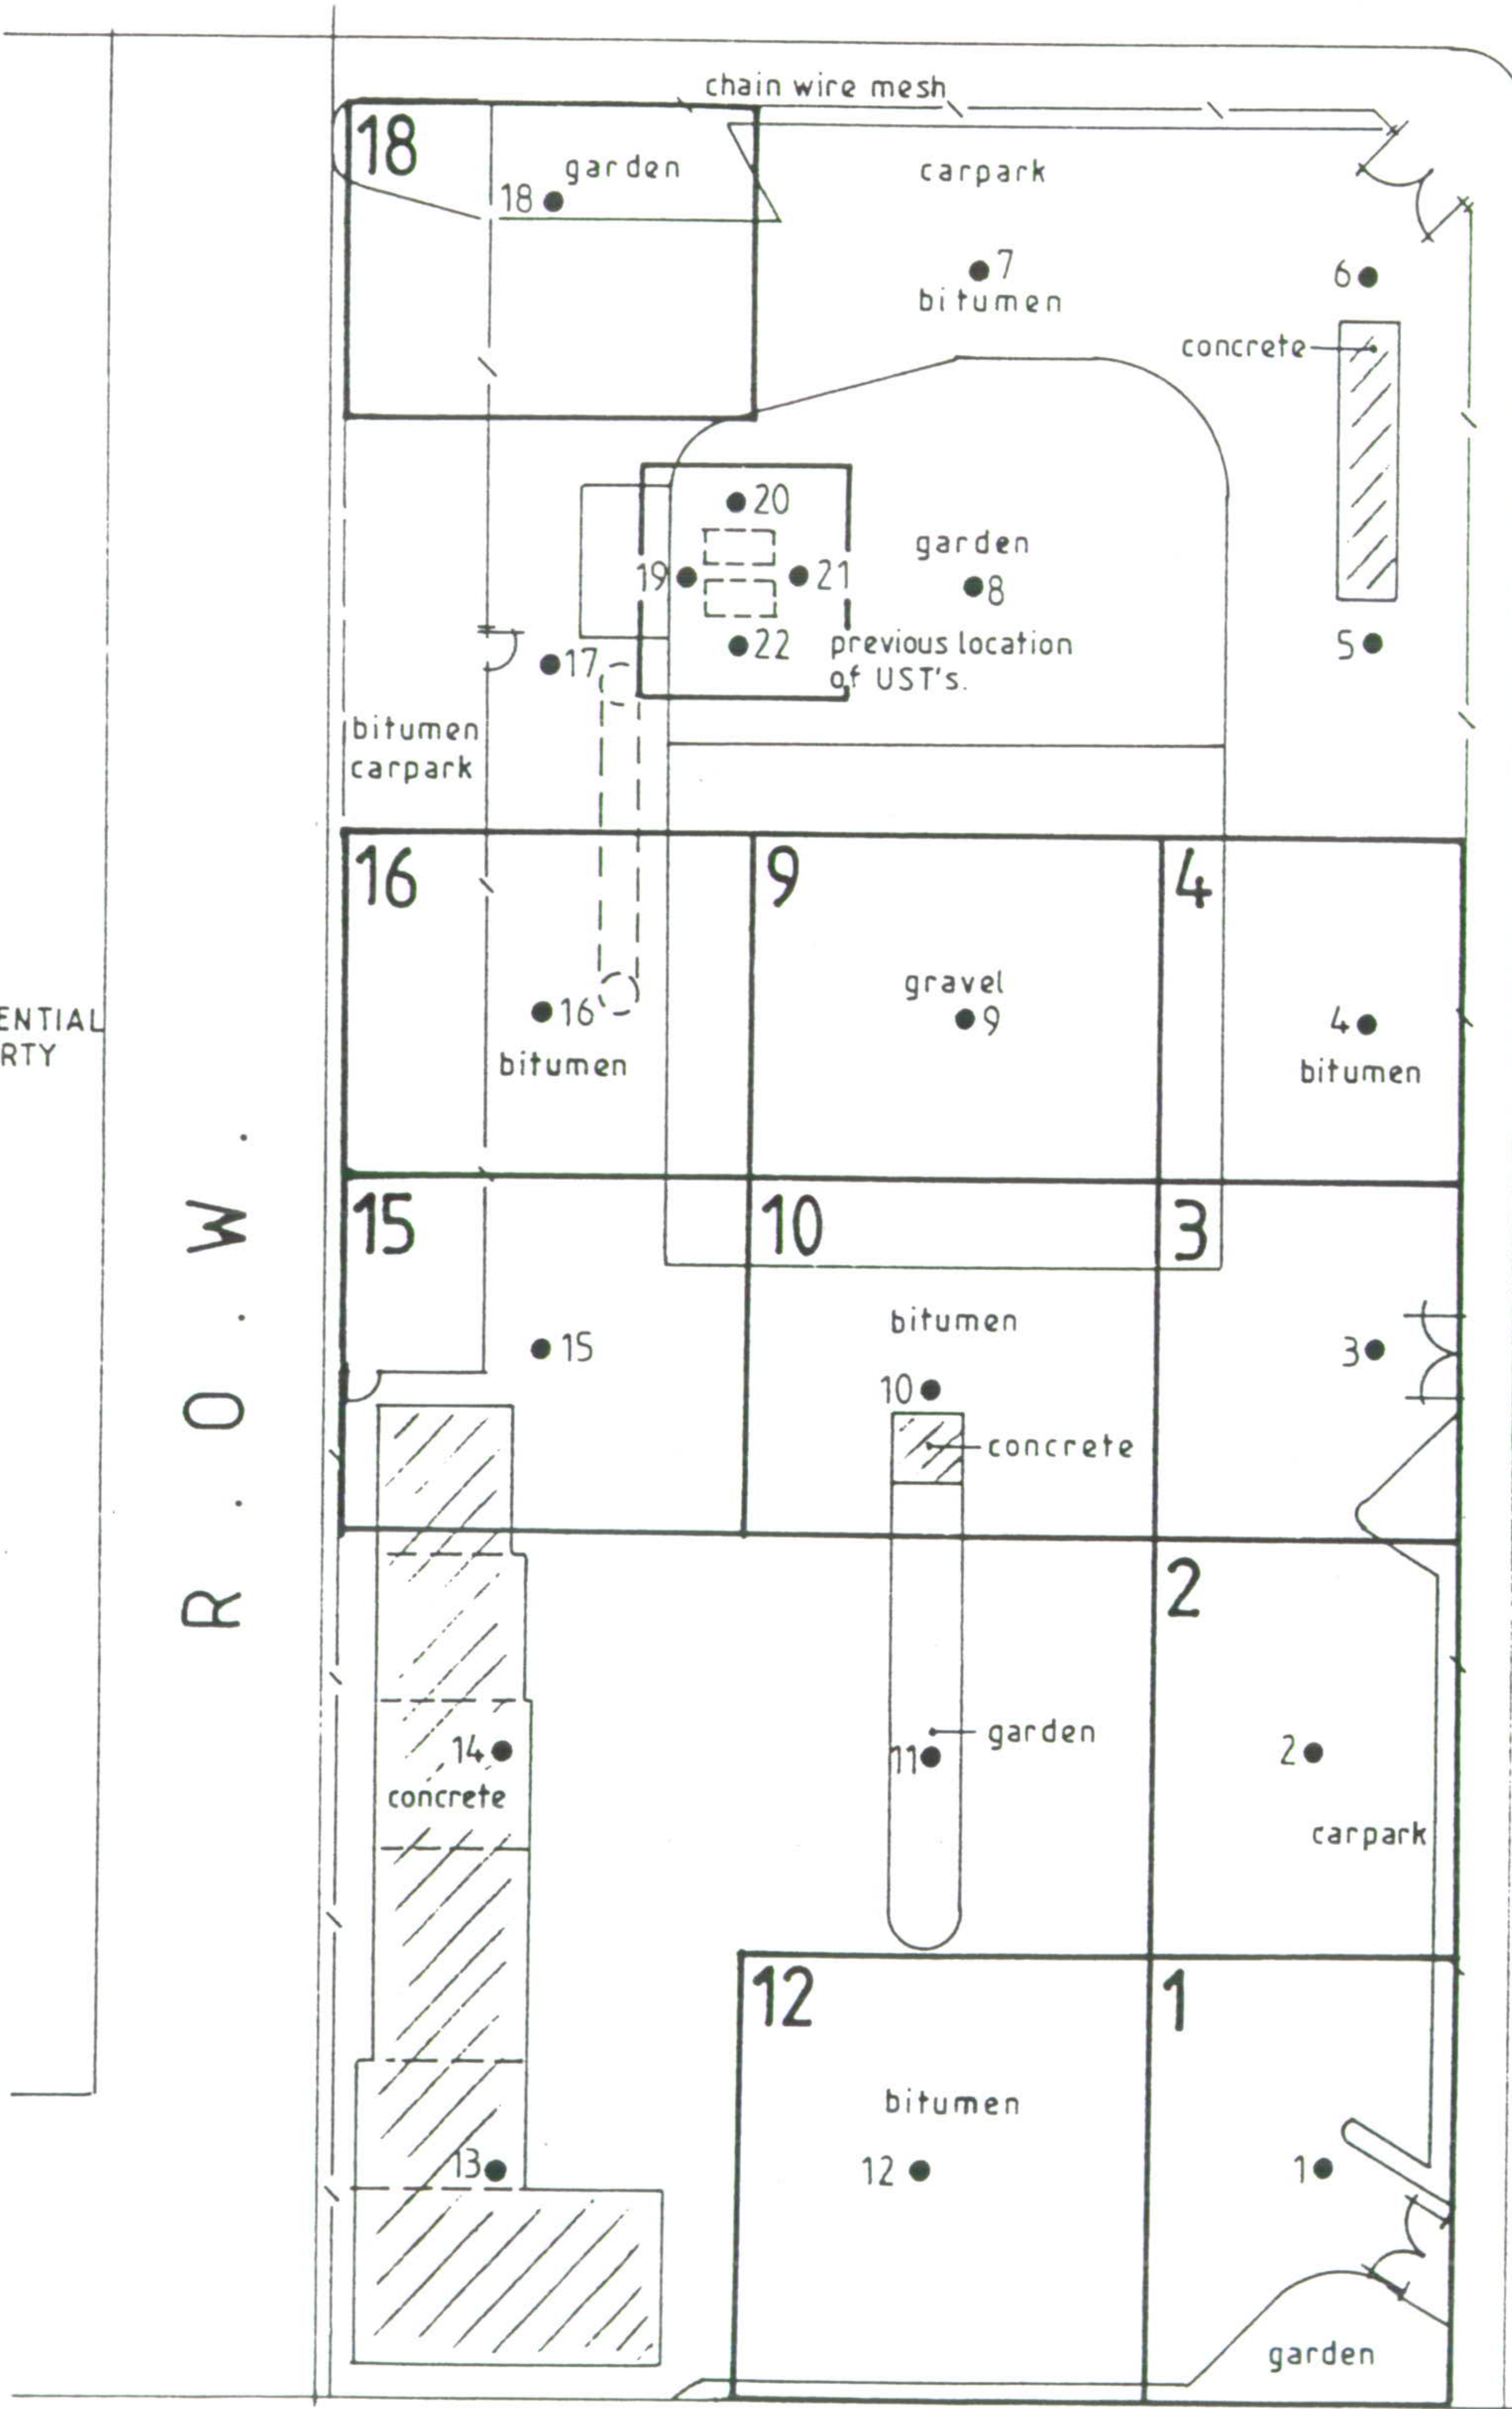
**SITE REMEDIATION AREAS**

On the basis of the risk assessment, ASA concluded that remediation of the area of the site as shown in Appendix B was necessary. These cells are listed in Table 5. 1.

Cell number	Remediation depth(m)
1	350
2	500
3	350
4	350
9	500
10	350
12	350
15	350
16	350
18	250

The Remediation Management Plan (RMP) sets out the approach to remediation of the areas identified in the July 1996 ASA Risk Assessment report and a program for validation of the cleanup works. Remediation was proposed by excavation and off-site disposal to a landfill licensed to accept low level contaminated soil. As noted, the extent of remediation proposed for areas where levels of nickel, zinc and mercury were elevated, was considered acceptable to the Auditor.
