## **ENVIRONMENTAL AUDIT REPORT (s53V)**

**18-22 Hamlet St, Cheltenham**

**Nuplex Industries  
(Aust) Pty Ltd**

**September 2011**

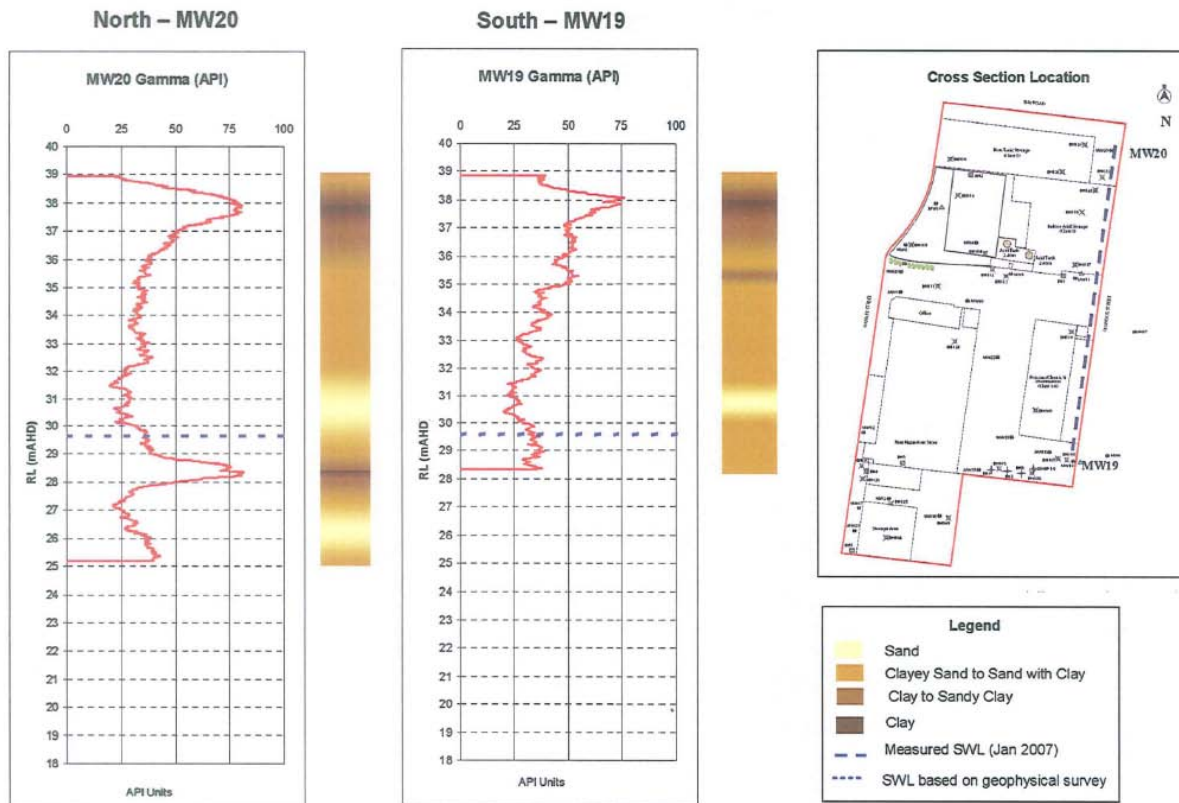
Figure 4-1: Geophysical Logs parallel to Section A-A'

The Auditor notes that the borehole logs generally do not identify silt layers or silty sand layers, which are very likely to be present at the site (and which have a bearing on hydrogeological properties). Further, the Auditor considers that this silty clay layer is unlikely to be either continuous or a barrier to vertical migration of DNAPL or other contaminants by vertical gradients (if present).

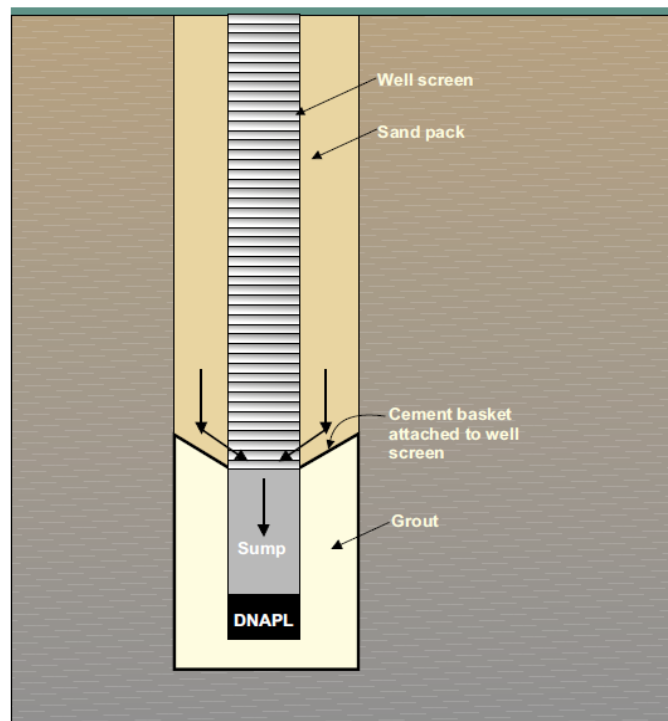
Figure 4-3: Monitoring Well Design for DNAPL Sites (AFCEE, 2000)

24. As well and sampling artefacts have affected data quality at this site, in-situ measurement devices to monitor water levels and geochemistry data are required to be part of the program developed within the GQMP. This should include down-hole data loggers with water level, temperature, conductance, DO and redox (in the sandy clay and lower sandy portions of the aquifer(s) impacted by plumes and one upgradient location).
25. As matrix interference has affected data quality, the SMP should consider alternative sampling methods to reduce the LORs to acceptable levels. Non-detection levels (LORs) should be discussed and presented in tables and figures.

| Aspect | Recommendation | | Recommended Completion Timetable |
|---|---|---|---|
| Monitoring Well Network - DNAPL | 15 | Construction of monitoring wells will need to include consideration of presence of DNAPLs (refer to Figure 4-3) including: well location, well screening (elevation, length and slot size), the filter pack (potentially including fine mesh wire) and seal through fill layers); this is to identify DNAPL migration into the well, decrease well artefacts and provide samples representative of the aquifer. As noted above, the Auditor considers that deeper migration of DNAPL(s) at the site is likely to have occurred. Therefore, new wells would need to incorporate this issue. | Ongoing during planning for well installation |

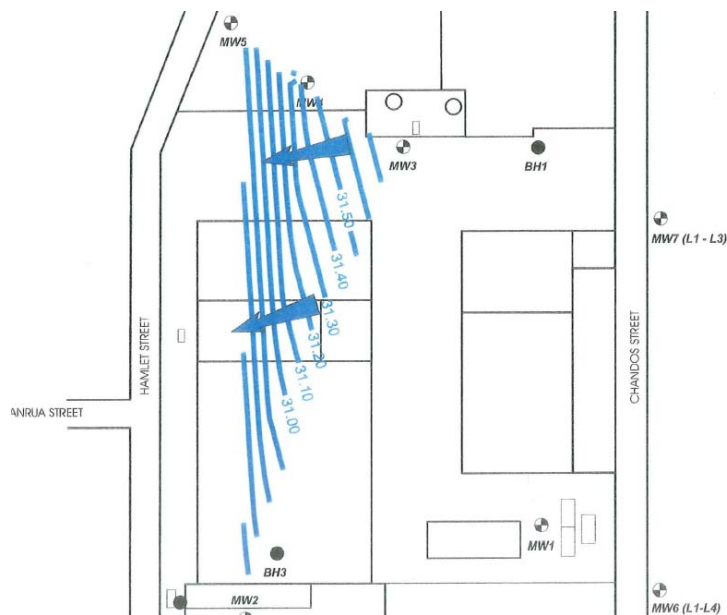
**Figure 4-4: Groundwater flow as shown in ERM (2001)**

Groundwater elevations and estimated flow direction were illustrated in the Assessors ESA report (GHD 2011), and historical figures of the ERM (2001) and SMEC (2006)<sup>16</sup> reports. With a more limited groundwater monitoring well network, the ERM (2001) report documented groundwater flow to the west (refer to Figure 4-4).

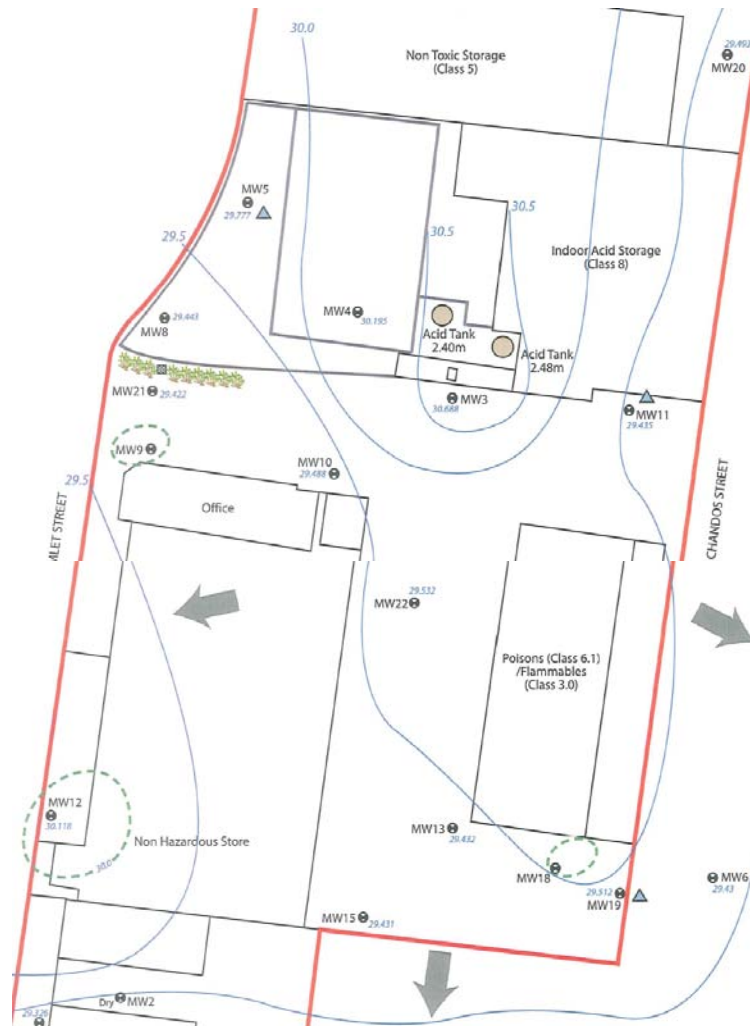
**Figure 4-5: Groundwater flow as shown in SMEC (2006)**

As shown on Figure 4-5, the SMEC (2007) report showed groundwater flow (shown to be flowing to the west, south and east) as affected by mounding in at least three areas of the site. Figure 4, Appendix A shows surface features (drainage grates, TITs, sumps, and UST excavation areas) that may be modifying shallow (and potentially deeper) groundwater flow at and from the site. This appears to be the case for the TIT near MW3, and the UST excavation area in the SEC near MW8. The mounding observed at MW9 and MW12 may be due to leaking water mains or other features.

the water levels to be "out of phase" with wells screened across higher permeability units, including fractures and sand seams in clayey media and/or coarser grained deposits.

The importance of understanding the groundwater flow directions from various areas of the site is related to the migration of plumes from source zones in these various current and former operational areas. The variation in flow directions presents multiple downgradient boundaries for the site, namely the west and southwest from the north-western portion of the site (including the Former Drum Storage Area), the east and southeast from the north-eastern portion of the site, and from the southwest to southeast in the southern portion of the site (including the SEC). The Auditor considers that a more robust understanding of the site groundwater flow (shallow, intermediate and deep) is required.

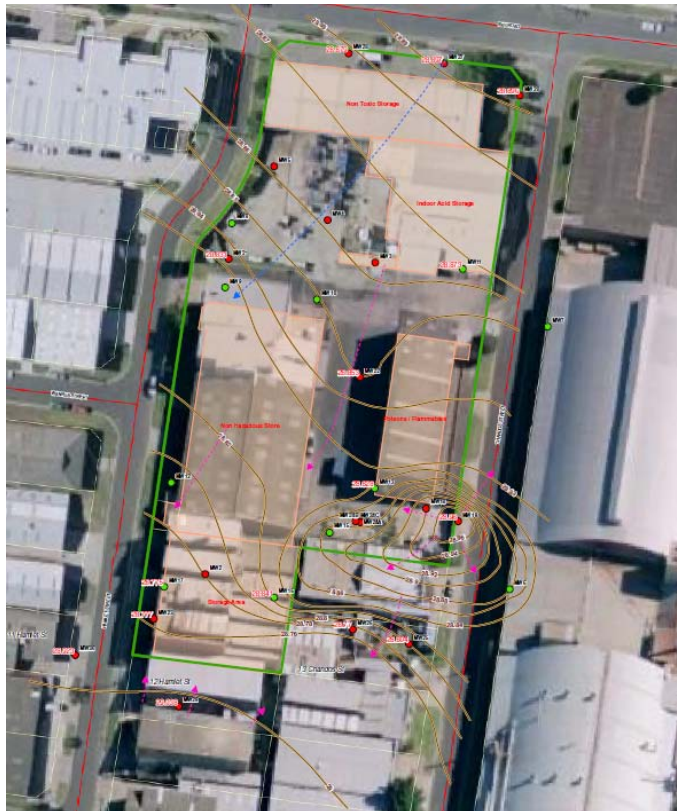
Figure 4-6: Groundwater flow as shown in GHD (2008)

Groundwater contours were interpreted in the Assessors ESA report (GHD 2011) to show that site groundwater was flowing in a south to south-west direction. As can be observed on this groundwater contour map (Figure 4-7), there are flow components to the southwest, south and southeast similar (but shifted to the east) to that shown in SMEC (2006).

Although flow to the south and west appears to be the most likely from the site location the potential presence of higher permeability river bed sand/gravel means that some deeper groundwater flow may be directed toward and along these higher permeability features, and may be migrating from the site along these pathways (may or may not follow regional flow).

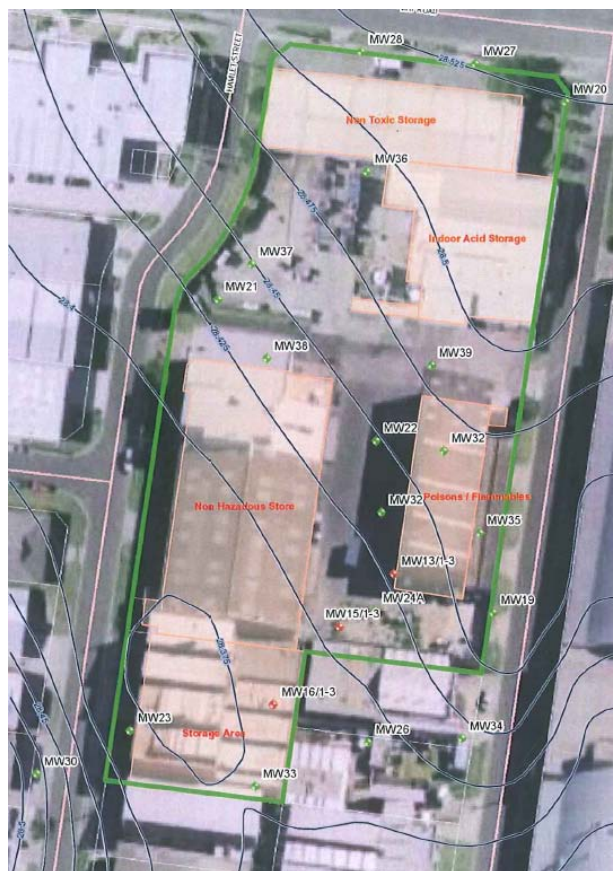
Figure 4-7: Groundwater flow as shown in GHD (2010)

Groundwater elevation data from January 2011 (GHD 2011) shows areas of localised mounding (MW4, MW12, MW40). The inferred groundwater flow pattern and direction has changed significantly over time due to the development of the monitoring network and temporal changes (which may be an artefact of bore construction as discussed earlier). GHD has inferred that there are leaky services (mains water and/or sewage) along Chandos Street and Hamlet Street.

| Aspect | Recommendation | | Recommended Completion Timetable |
|---|---|---|---|
| Hydraulic Control – Groundwater Flow Directions | 28 | On and offsite services be investigated to determine if they are leaking and effecting the groundwater flow pattern and contaminant transport | 6 months |

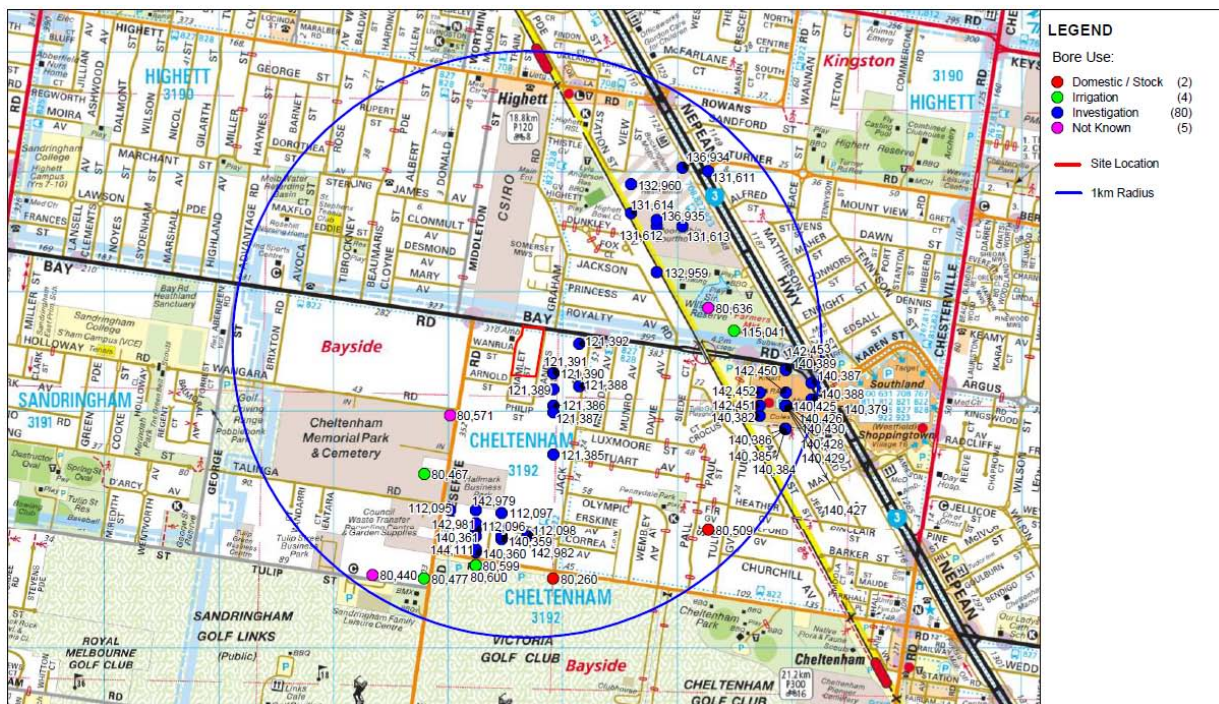
Figure 4-8: Registered Groundwater Bores within 1 km of Site (GHD 2010)

These results show there are eleven registered bores which could potentially be used for groundwater extraction. Groundwater may be utilised by persons with unregistered bores, or registered bores that have not yet appeared on the database.

| Aspect | Recommendation | | Recommended Completion Timetable |
|---|---|---|---|
| Groundwater Resources – Supply Well Information | 32 | Seek to obtain groundwater extraction and water supply well information for the above-noted wells. | 6 months |

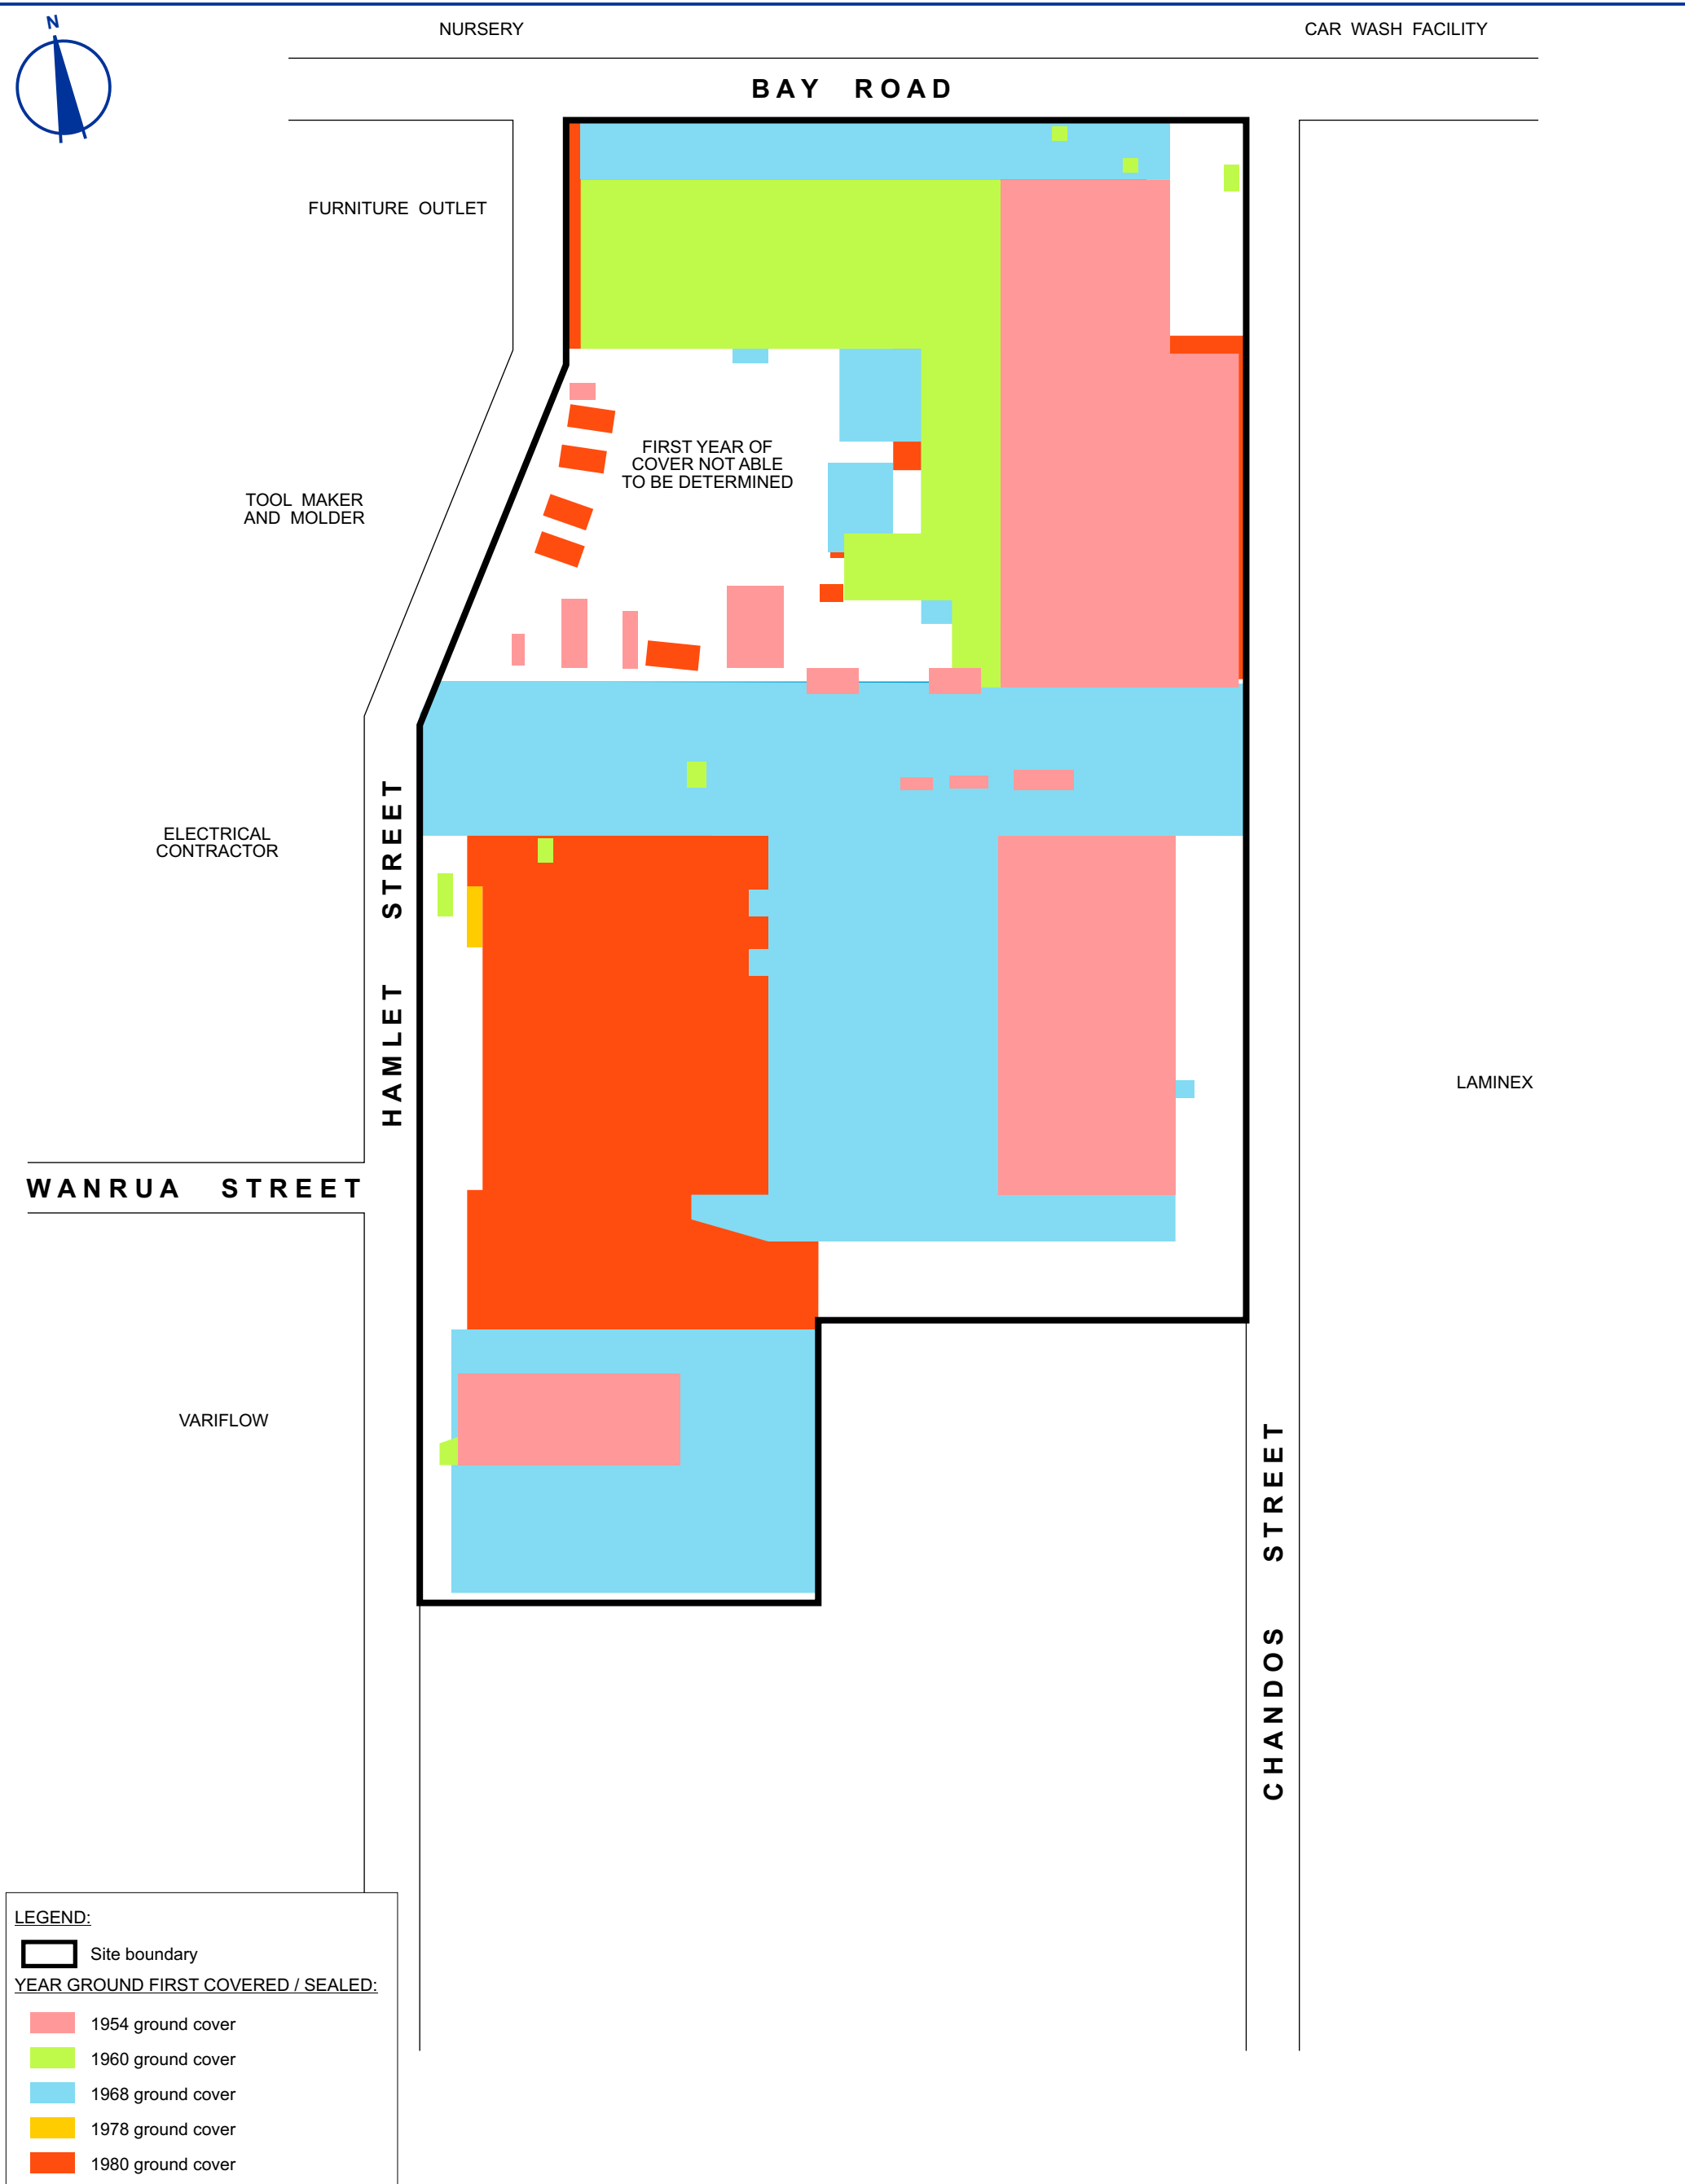
Base image After ERM 2001

| <div>LanePiper</div> <div>Lane Piper Pty Ltd</div> <div>A.C.N. 120 109 935</div> <div>www.lanepiper.com.au</div> | PROJECT: s53V Environmental Audit<br>18-22 Hamlet Street,<br>Cheltenham, Vic. | | TITLE: Year Ground First Covered / Sealed | |
