## Statement of Environmental Audit

Lot 3, 14 Hamlet Street, Cheltenham, Victoria

**ENVIRONMENT PROTECTION ACT 1970**  
**STATEMENT OF ENVIRONMENTAL AUDIT**

# WAREHOUSE MIXED DEVELOPMENT

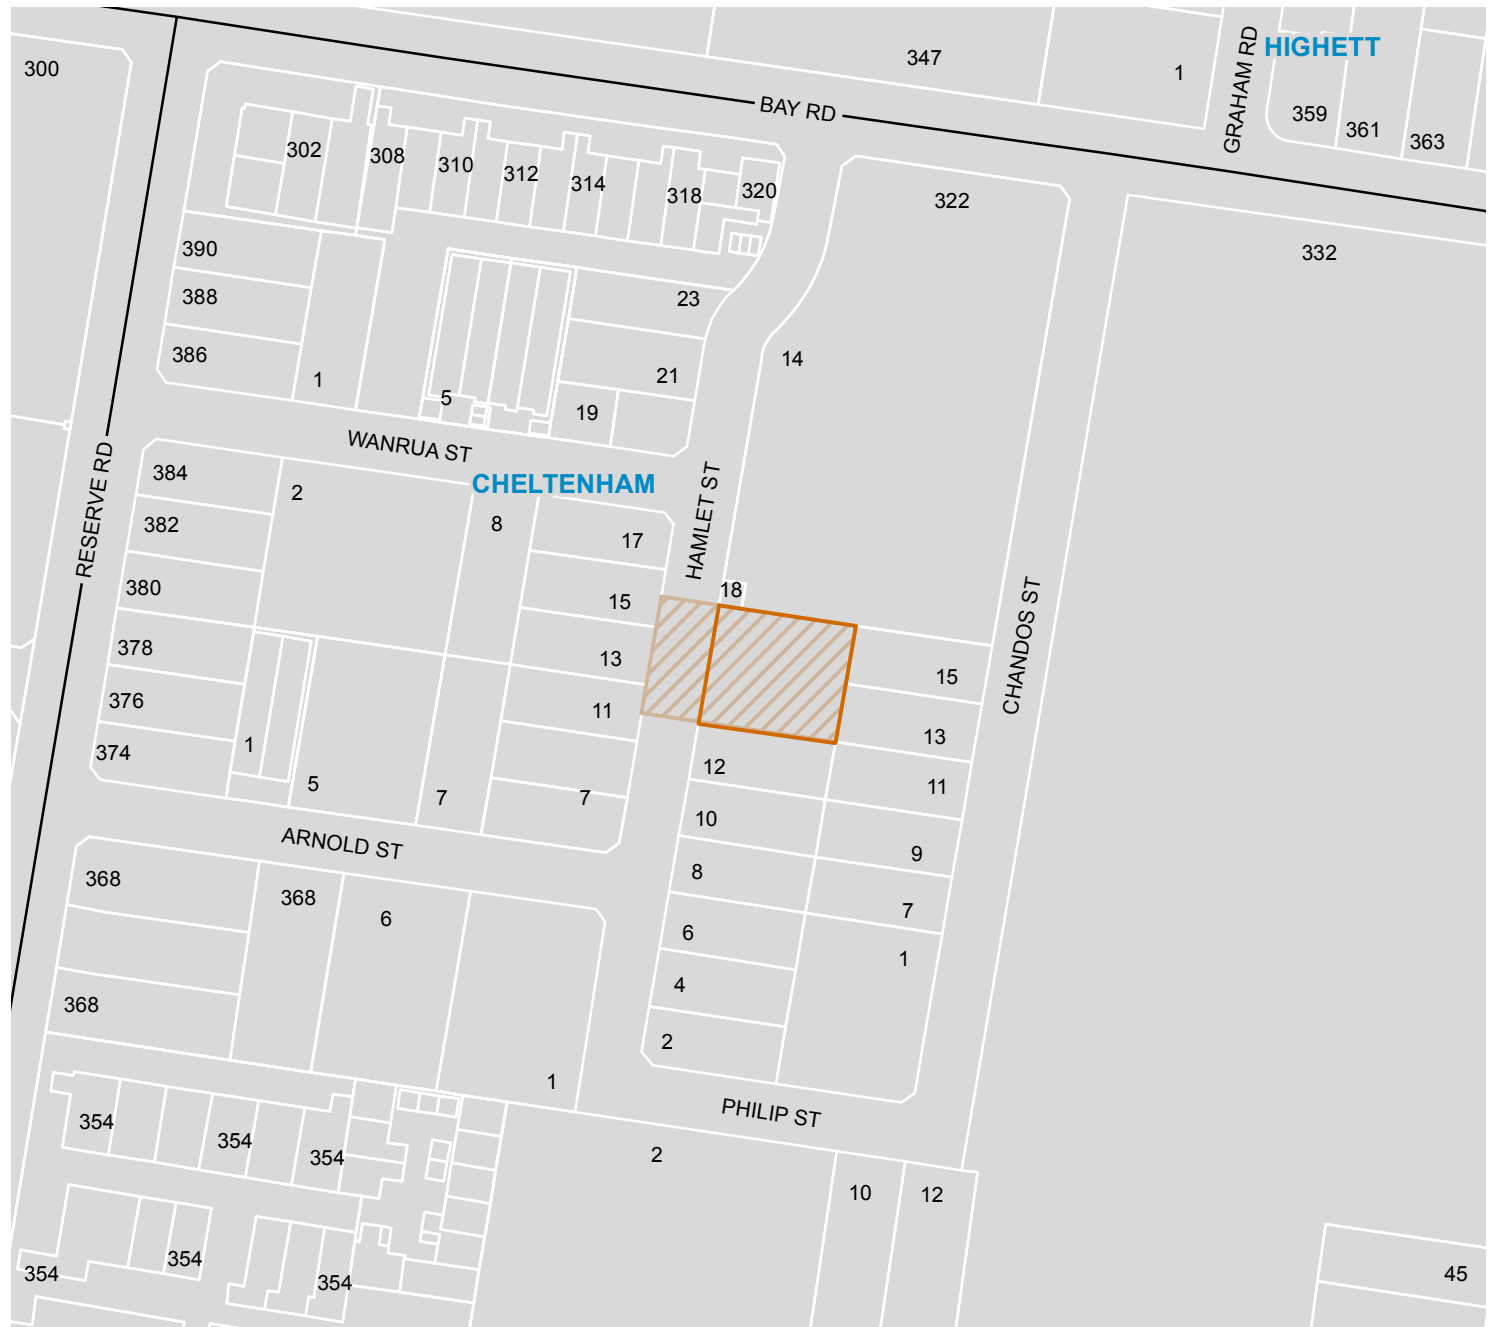
# Groundwater zone with restricted uses

Disclaimer: The map represents an approximate estimation of an area where groundwater quality has been impacted by human activities. It does not provide information on the naturally occurring quality of groundwater, which can also have restrictions on its use. The environmental audit boundary and groundwater zone are based on land parcel boundaries at the time of mapping. Subsequent changes to land parcel boundaries do not change the location of the zone.

- 1) On 10 September 2019 the Authority determined that;
  - (i) groundwater had been cleaned up to the extent practicable, and
  - (ii) the site is within a Groundwater Quality Restricted Use Zone (GQRUZ). The extent of the GQRUZ is shown on the Authority GQRUZ Figure attached to this Statement of Environmental Audit.
