# **ENVIRONMENTAL AUDIT REPORT**

**1-5 Ballarat Road  
NORTH GEELONG, VIC**

**EPA CARMS Ref 74722-2  
EPA Service Order Number 8005814**

**Date: 13 May 2019**

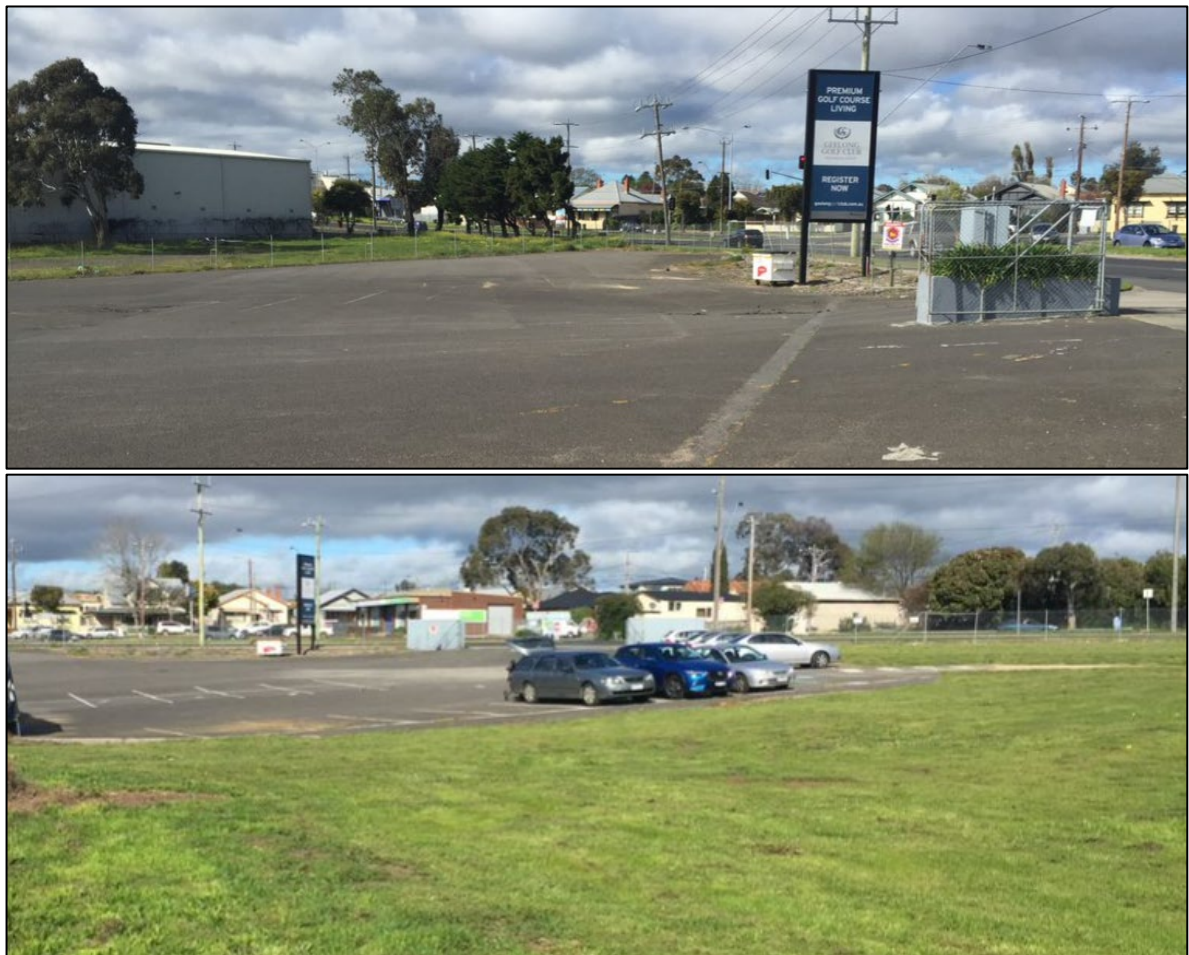
*Figure 2. Site Photographs (2018)*

The Site is irregular in shape and covers approximately 6,277m<sup>2</sup>. At the time the audit was commissioned (August 2016), the site was vacant land with asphalt hardstand remaining in the western portion of the site and grassed/unsealed surface in the eastern portion. No buildings or structures (with the exception of metal fencing) were present on the site. The conditions have not changed appreciably since then.

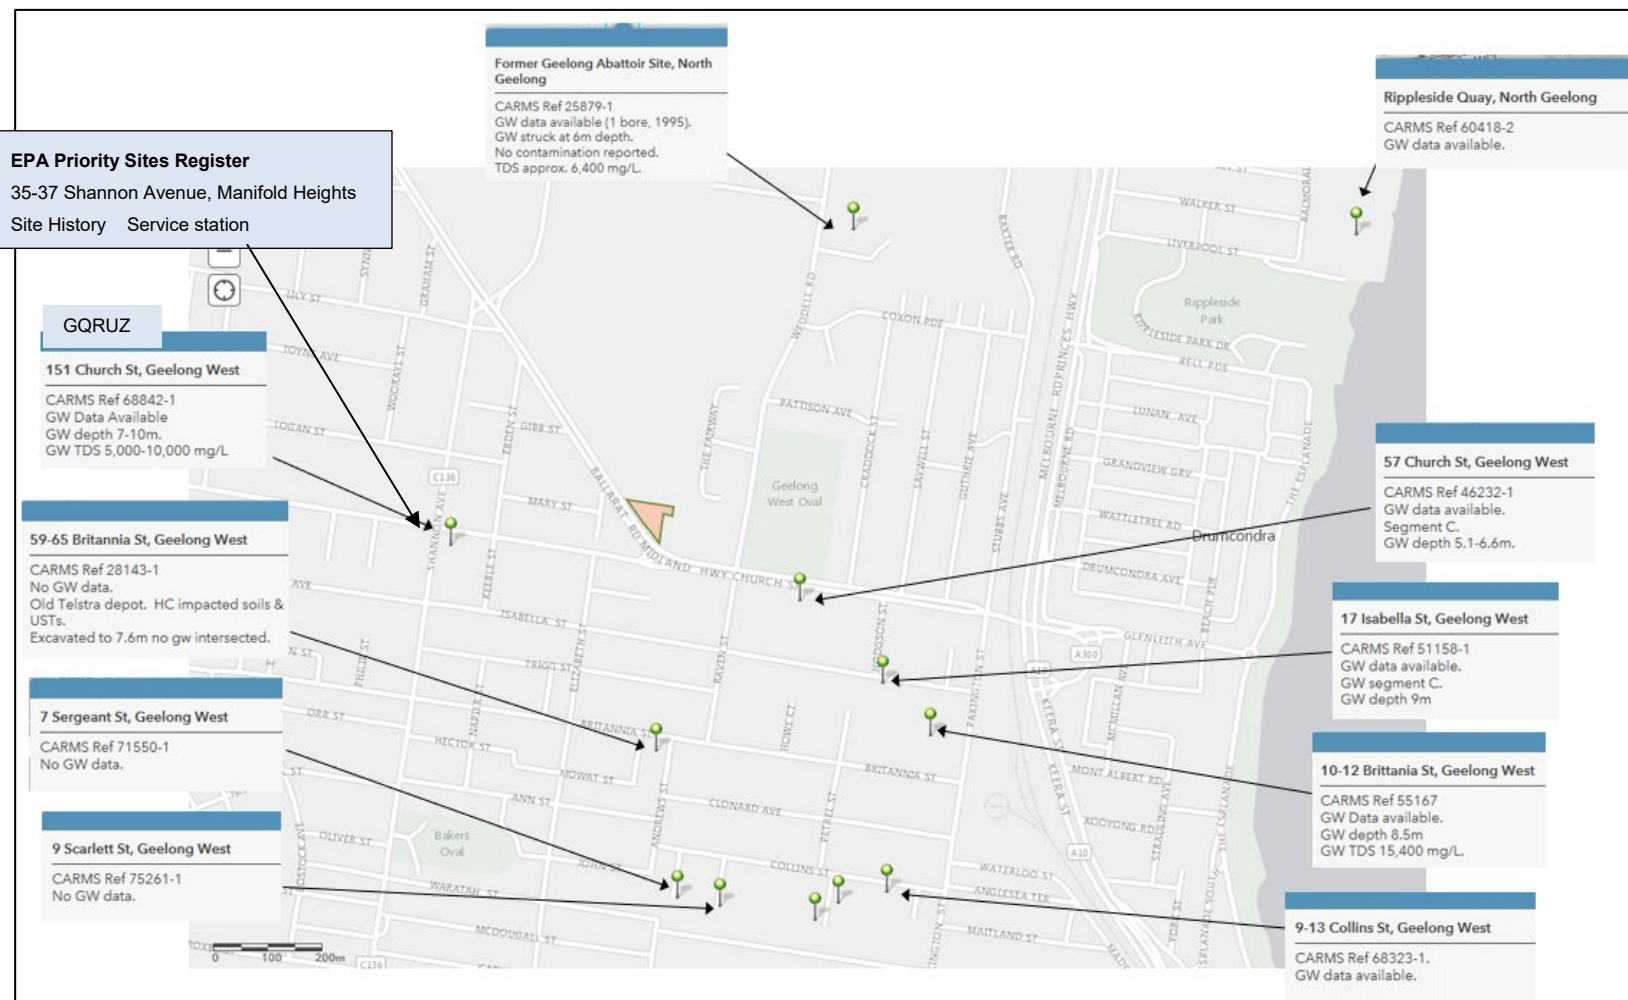
Figure 7. Environmental Audit Reports completed in area and other sites of interest

- **57 Church St, Geelong West (EPA CARMS 46232-1, SoEA). Approximately 275m E of the site (2004).** Former service station and mechanic. Features noted included 11 USTs, hydraulic hoist, vehicle pit and triple interceptor trap. Groundwater was reportedly encountered between 5.1m and 6.1m depth. Multiple rounds of groundwater monitoring were undertaken on bores located on and offsite monitoring wells located on and offsite. Groundwater was assessed as Segment C (superseded SEPP (Groundwaters of Victoria)) and TPH, ethylbenzene and xylene impacts were identified in a plume identified offsite and down-gradient to the east towards Corio Bay. EPA confirmed that groundwater pollution had been cleaned up “to the extent practicable”, and a Statement of Environmental Audit was ultimately issued with a requirement for ongoing groundwater management.

- **151-153 Church Street, North Geelong (EPA CARMS Ref 68842-1, SoEA). Approximately 370m W of the site (2012).** Former service station and workshop. Features noted included lubricant bay, 6 USTs and triple interceptor trap. Groundwater was assessed as segment C (superseded SEPP (Groundwaters of Victoria)), with groundwater present between 7m and 11m depth. Inferred groundwater flow was E-NE towards Corio Bay, with the site assessment including a monitoring well network of 51 onsite and offsite wells. Groundwater was identified to be impacted by TPH, BTEX, lead, PAH and phenols and LNAPL was historically present onsite. Extensive remediation was completed and eventually EPA confirmed that groundwater pollution had been cleaned up “to the extent practicable”. A Statement of Environmental Audit was issued with a requirement for ongoing groundwater management. A GQRUZ was imposed to the east of the site, however it does not encumber the site itself.

- **5-9 Donaghy Street, West Geelong (EPA CARMS Ref 68289-1). Approximately 790m SE of the site (2011).** The site formed a part of the Donaghy rope factory, with 10 USTs removed from the site. Groundwater was encountered at 7-8m depth. Historical fill was present on the site with identified elevated concentrations of arsenic, copper, nickel and TPH. Groundwater was found to contain elevated nitrate, nitrite and selenium (deemed to be associated with a leaking sewer near the site, and boron, chromium, chloride, copper, sodium and zinc determined likely to be naturally elevated. A Statement of Environmental Audit was issued with a condition requiring maintenance of a cap to limit site soil exposure and a prohibition on extractive water use.
