This Statement forms part of the Environmental Audit Report: GHD Pty Ltd, “*CSIRO, Environmental Audit Report, Grassy Woodland, 37 Graham Road, Highett, Victoria, CARMS Reference 68549-3, Service Order No. 8003038*” (May, 2020). Further details regarding the condition of the site may be found in the Environmental Audit Report.

## CSIRO Highett - Grassy Woodlands

Project No: 674398CH  
 Document Title: Environmental Management Plan  
 Document No.: 674398CH-0007-NP-RPT-0001  
 Revision: 4  
 Document Status: Final  
 Date: 22 May 2020  
 Client Name: Commonwealth Scientific and Industrial Research Organisation  
 Client No: -  
 Project Manager: Jye Grogan  
 Author: Jye Grogan / Monique Farmer / Liam Gooley  
 File Name: 674398CH-0007-NP-RPT-0001\_GrassyWoodland\_EMP\_Rev4

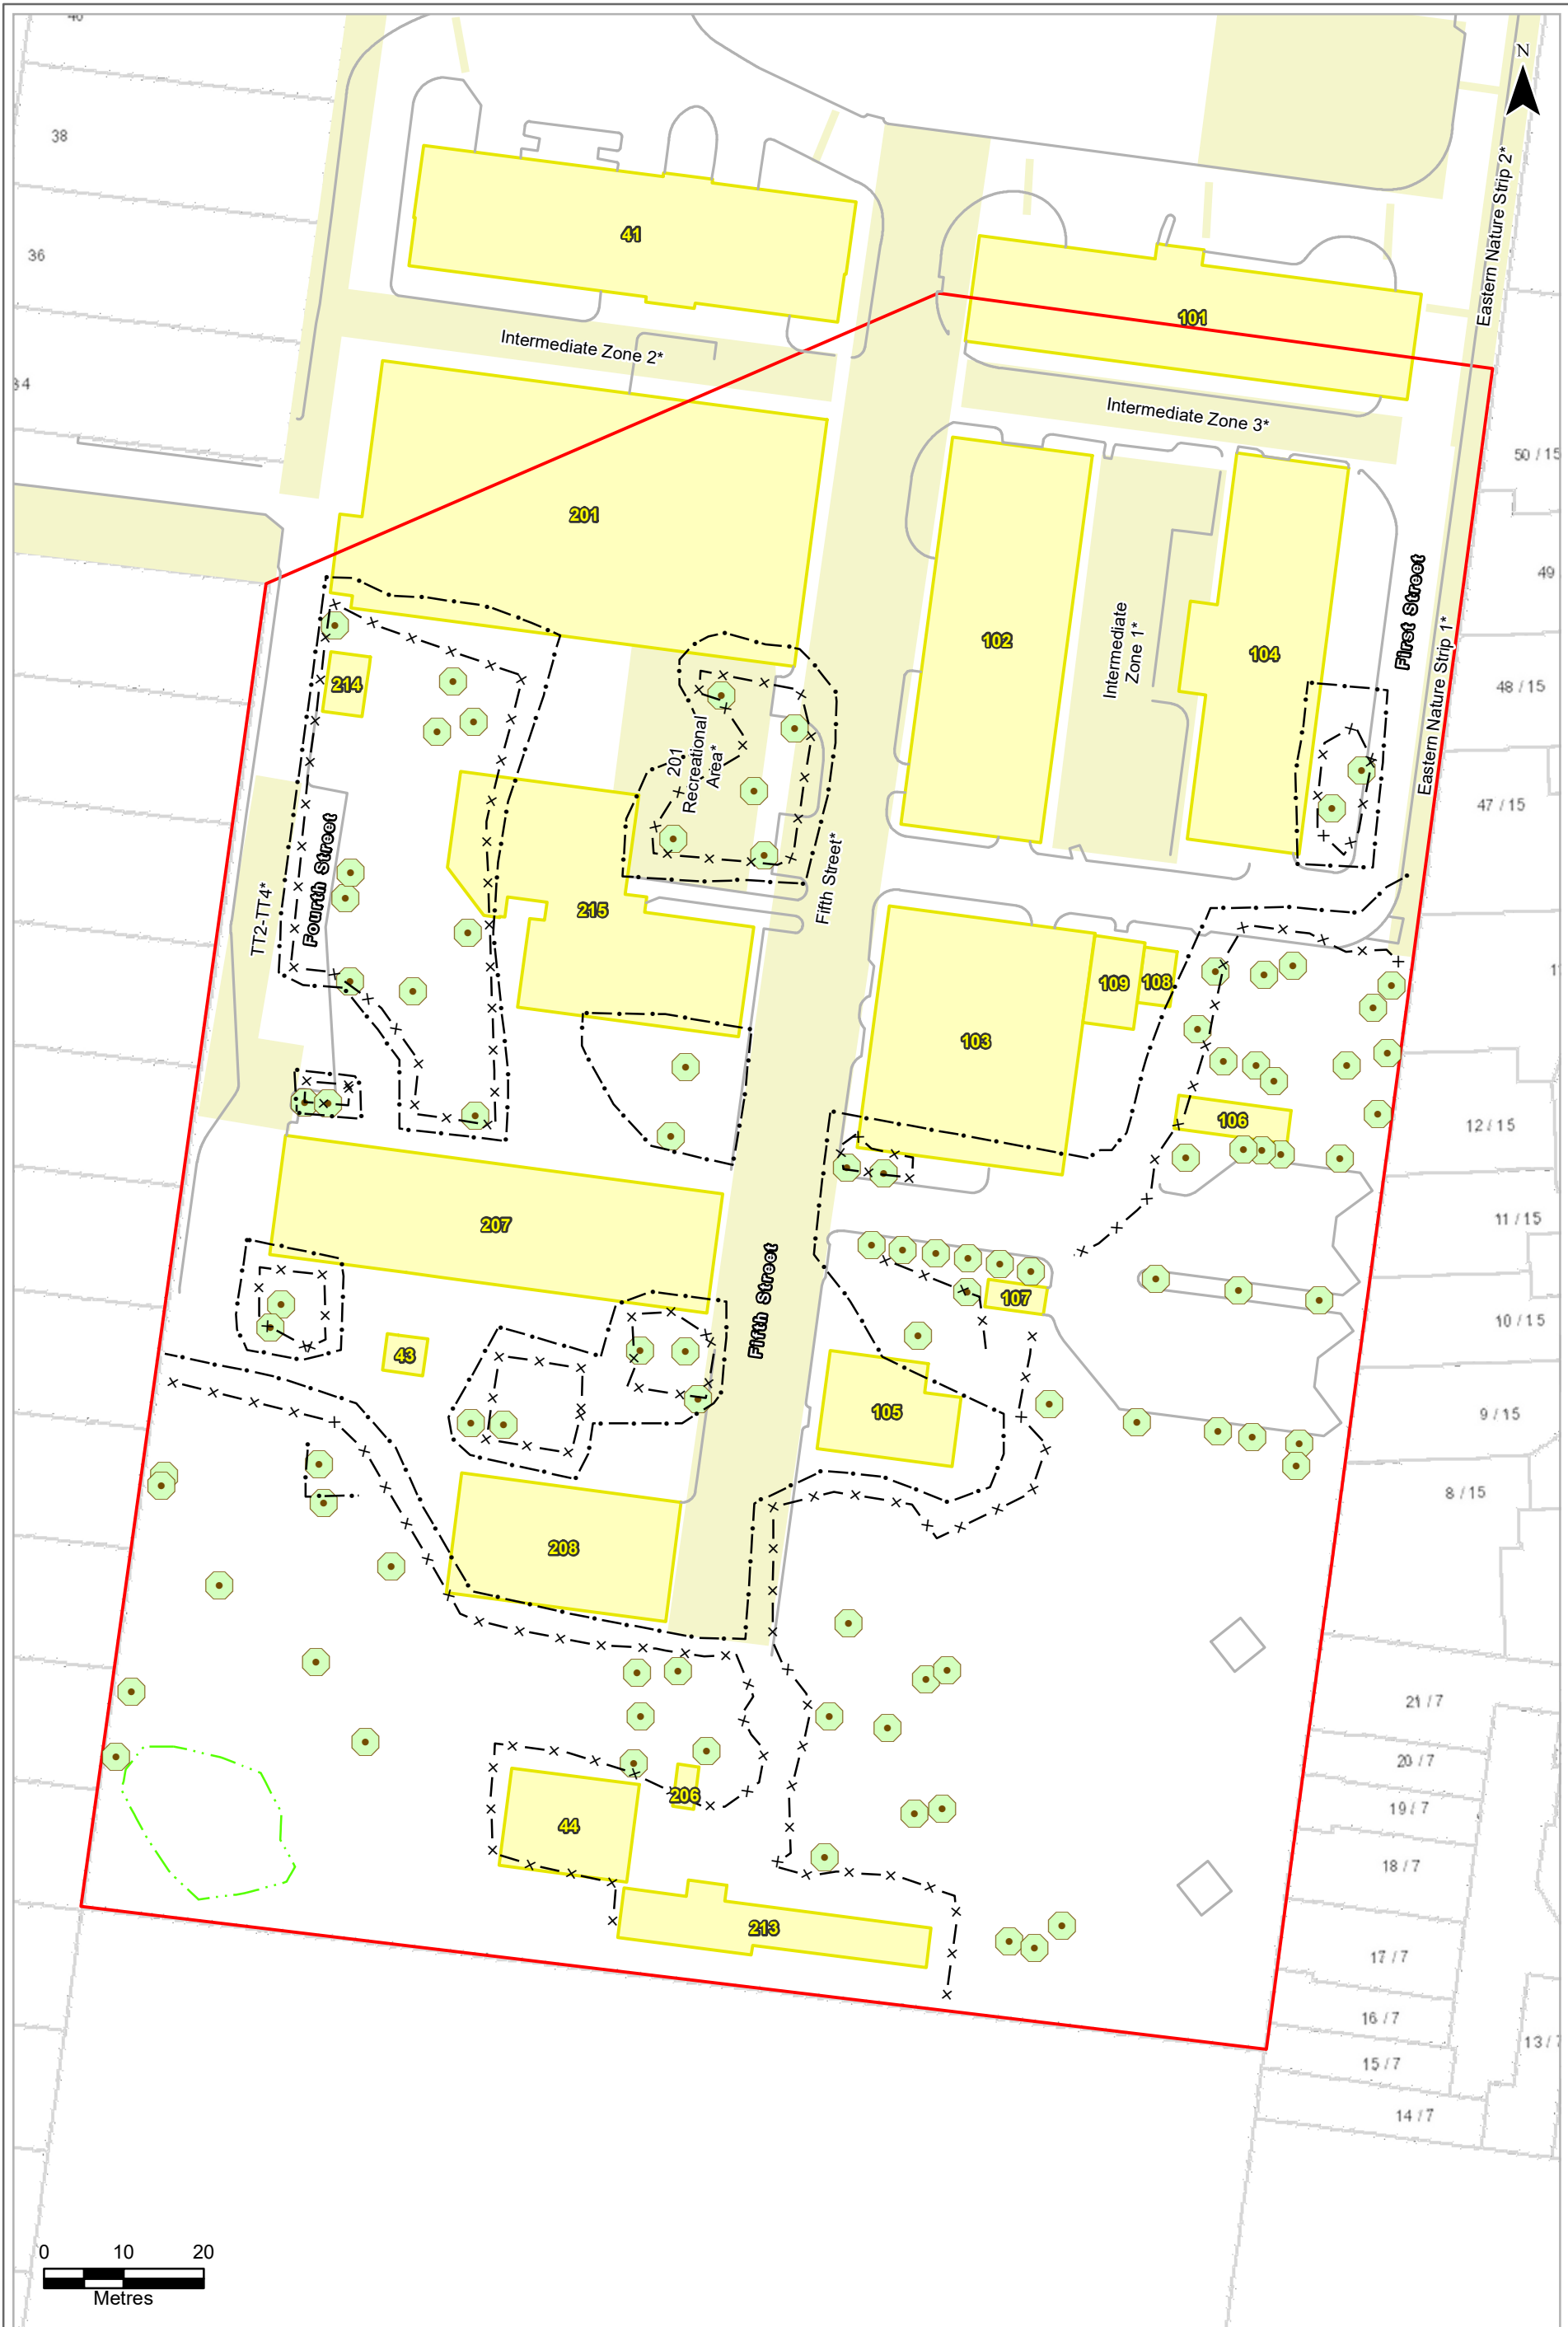
**FIGURE 2**  
**Remediated/Validated Footprints**

- Silt Barrier
- Tree Protection Fencing
- Concrete Curbs and Slabs
- Tree
- Former Building Footprint
- Non-building Footprint
- Former Grassy Mound
- Site Boundary

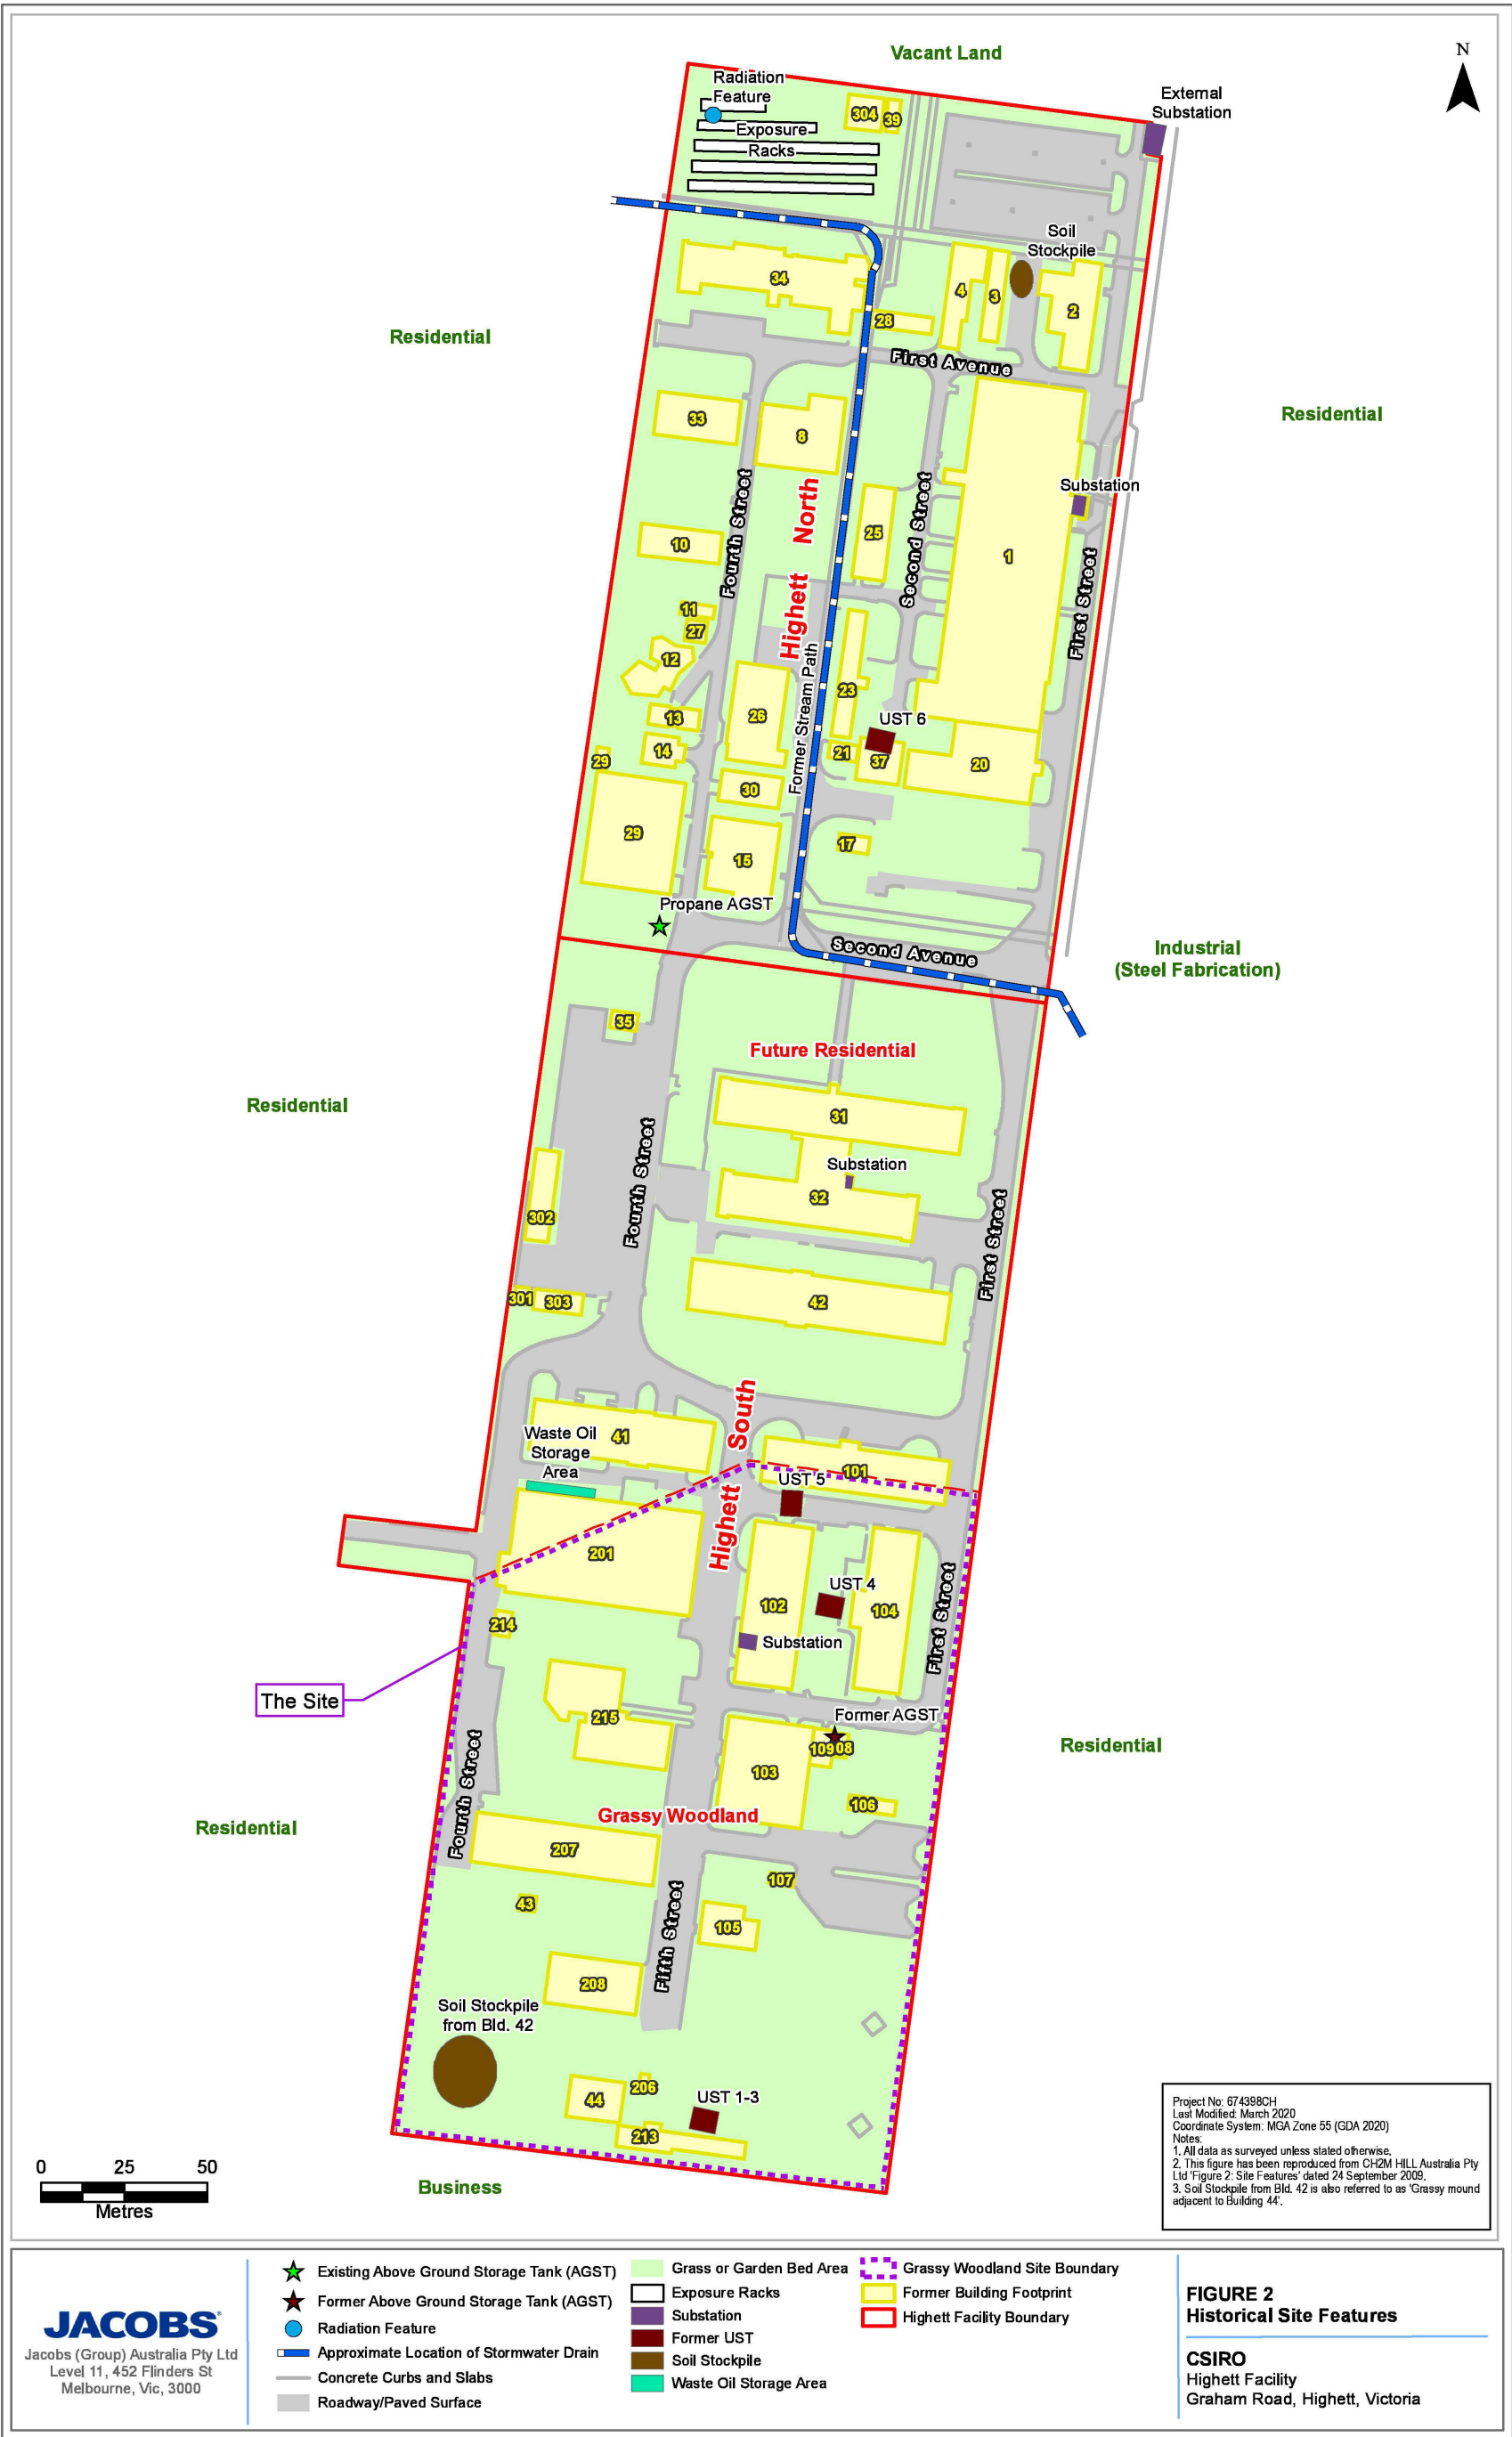
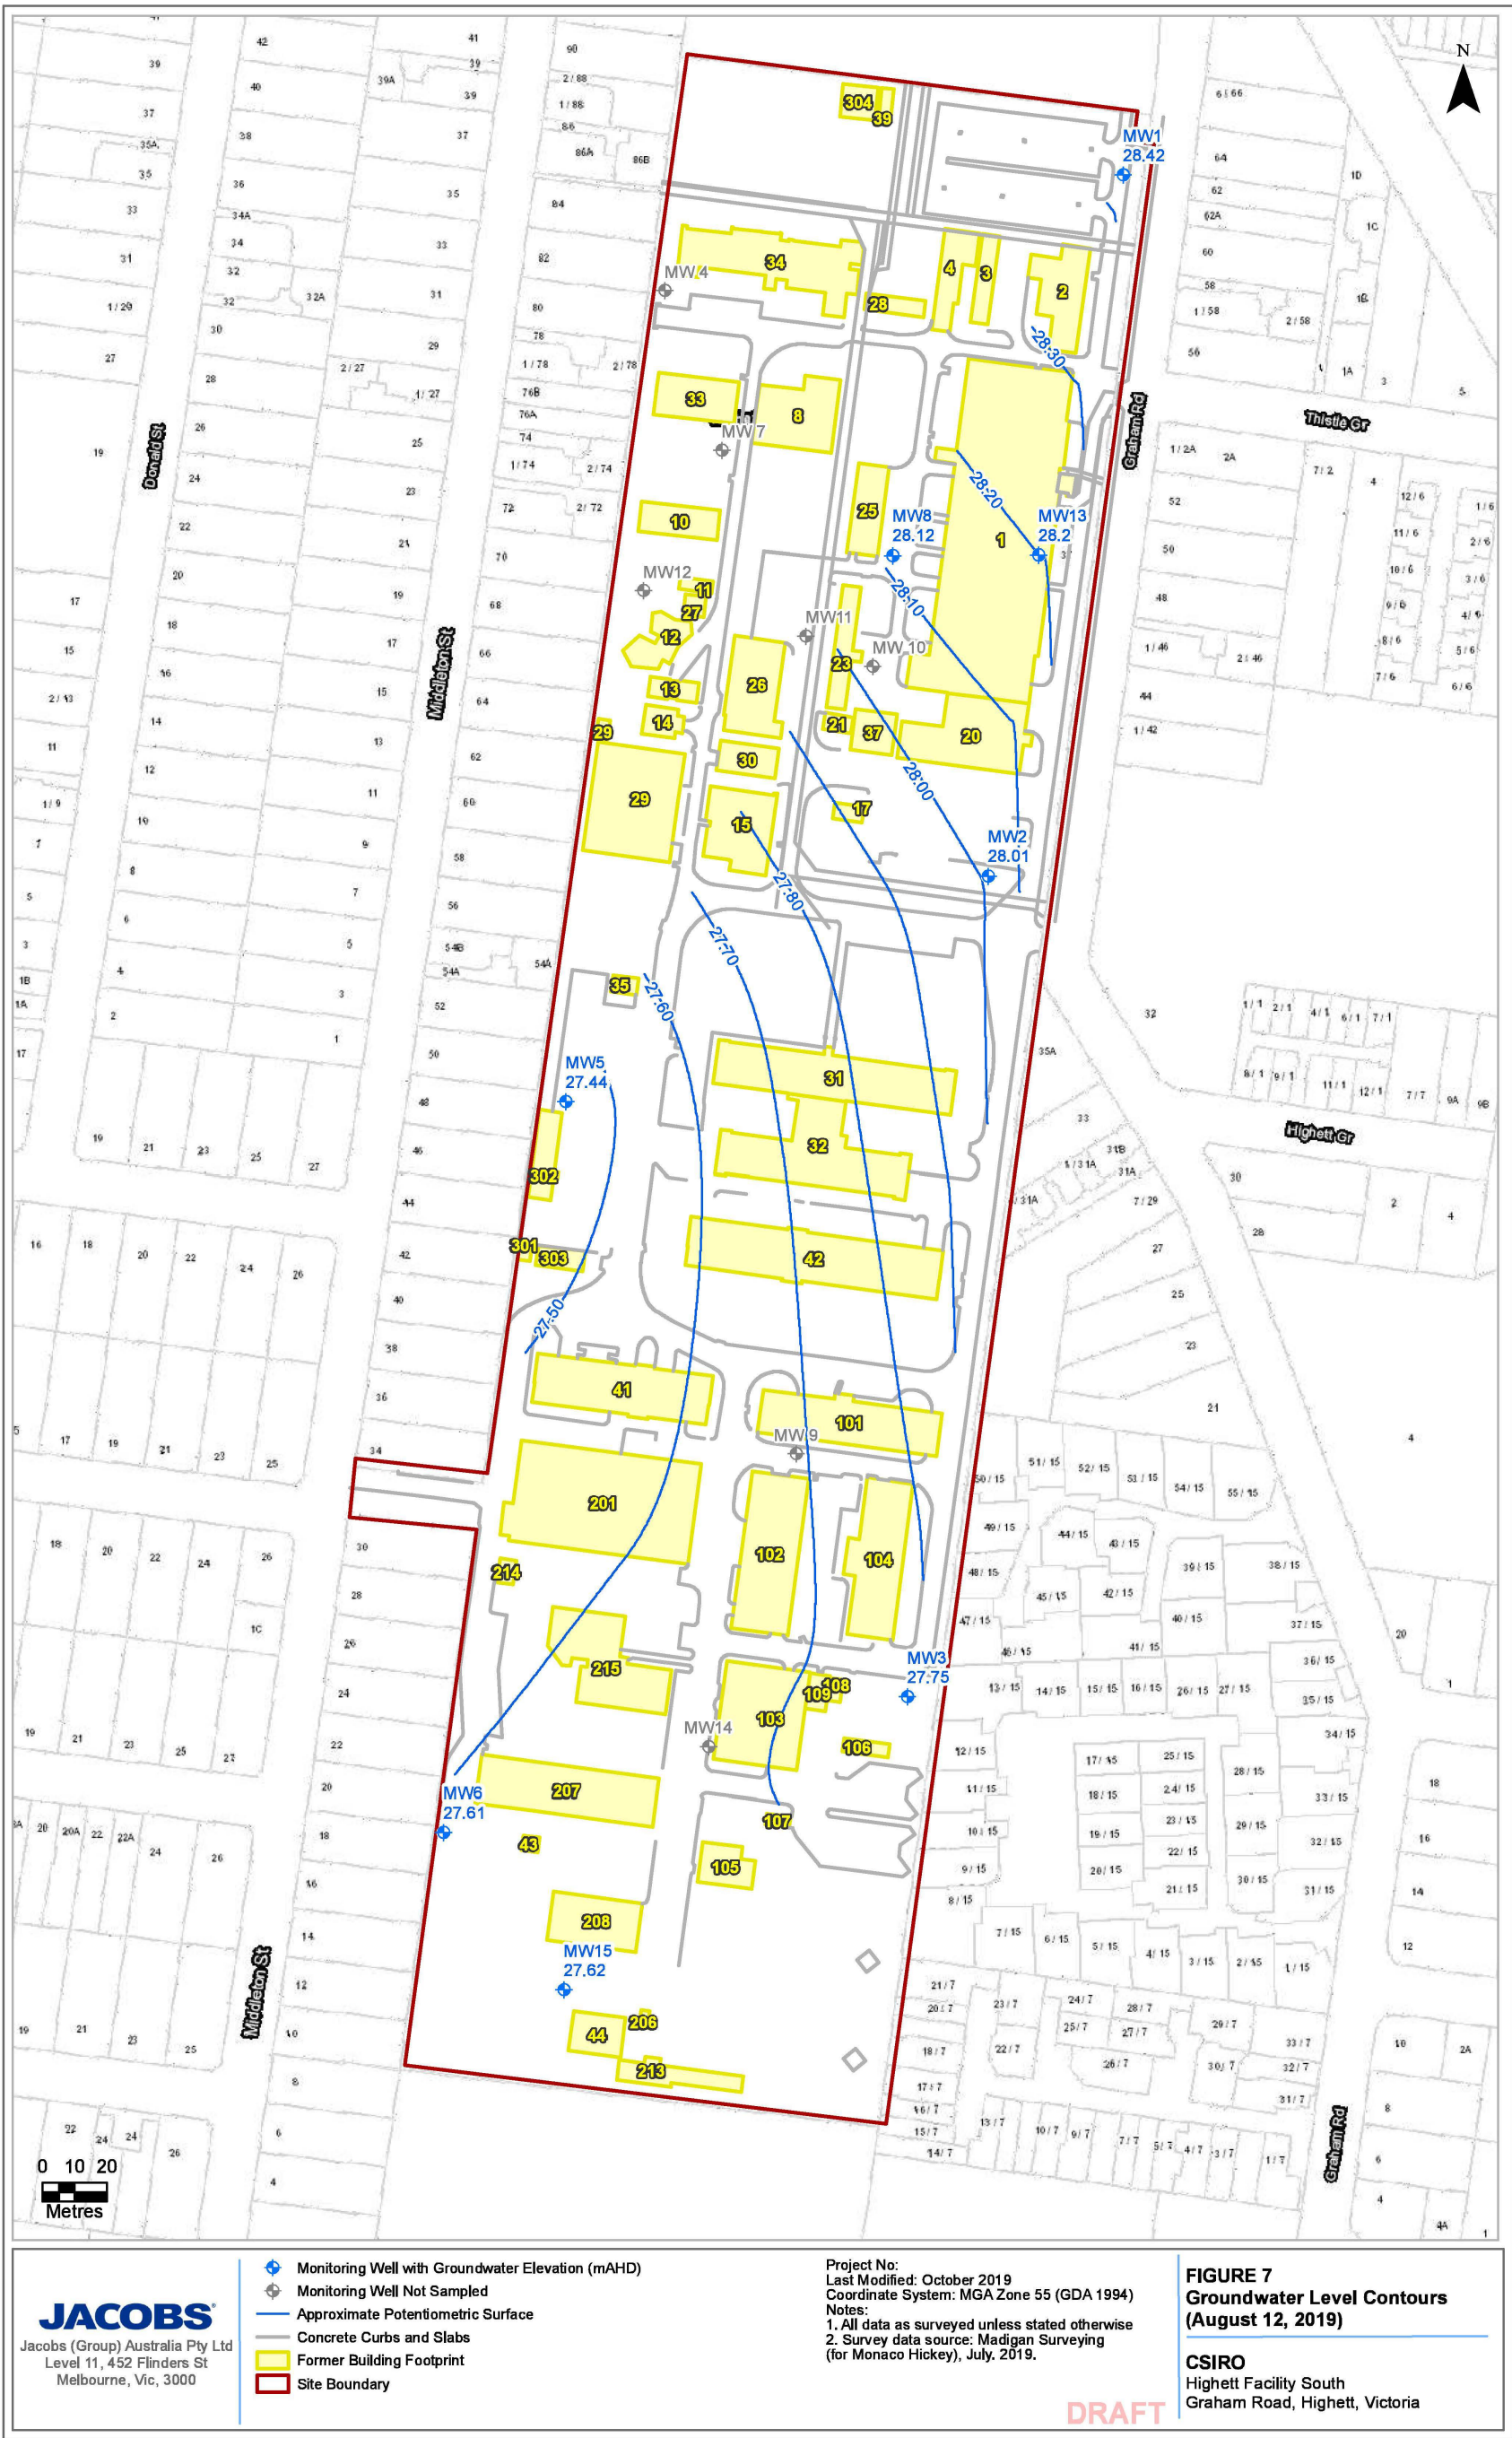
| Figure 1 | Boundary of CSIRO Grassy Woodland Audit Area |

Figure 1 of shows the location of 'Grassy Woodland' within the context of the larger CSIRO Site. This audit report is for the Grassy Woodland portion of the site (also known as 'audit site' or 'the site') only.
