# Environmental Audit Report Stages 2 and 2A

1136-1138 Nepean Highway Highett 3190 Victoria  
(CARMS #37308-2)

December 2011

# **GROUNDWATER QUALITY MANAGEMENT PLAN - STAGES 2 AND 2A Rev 2**

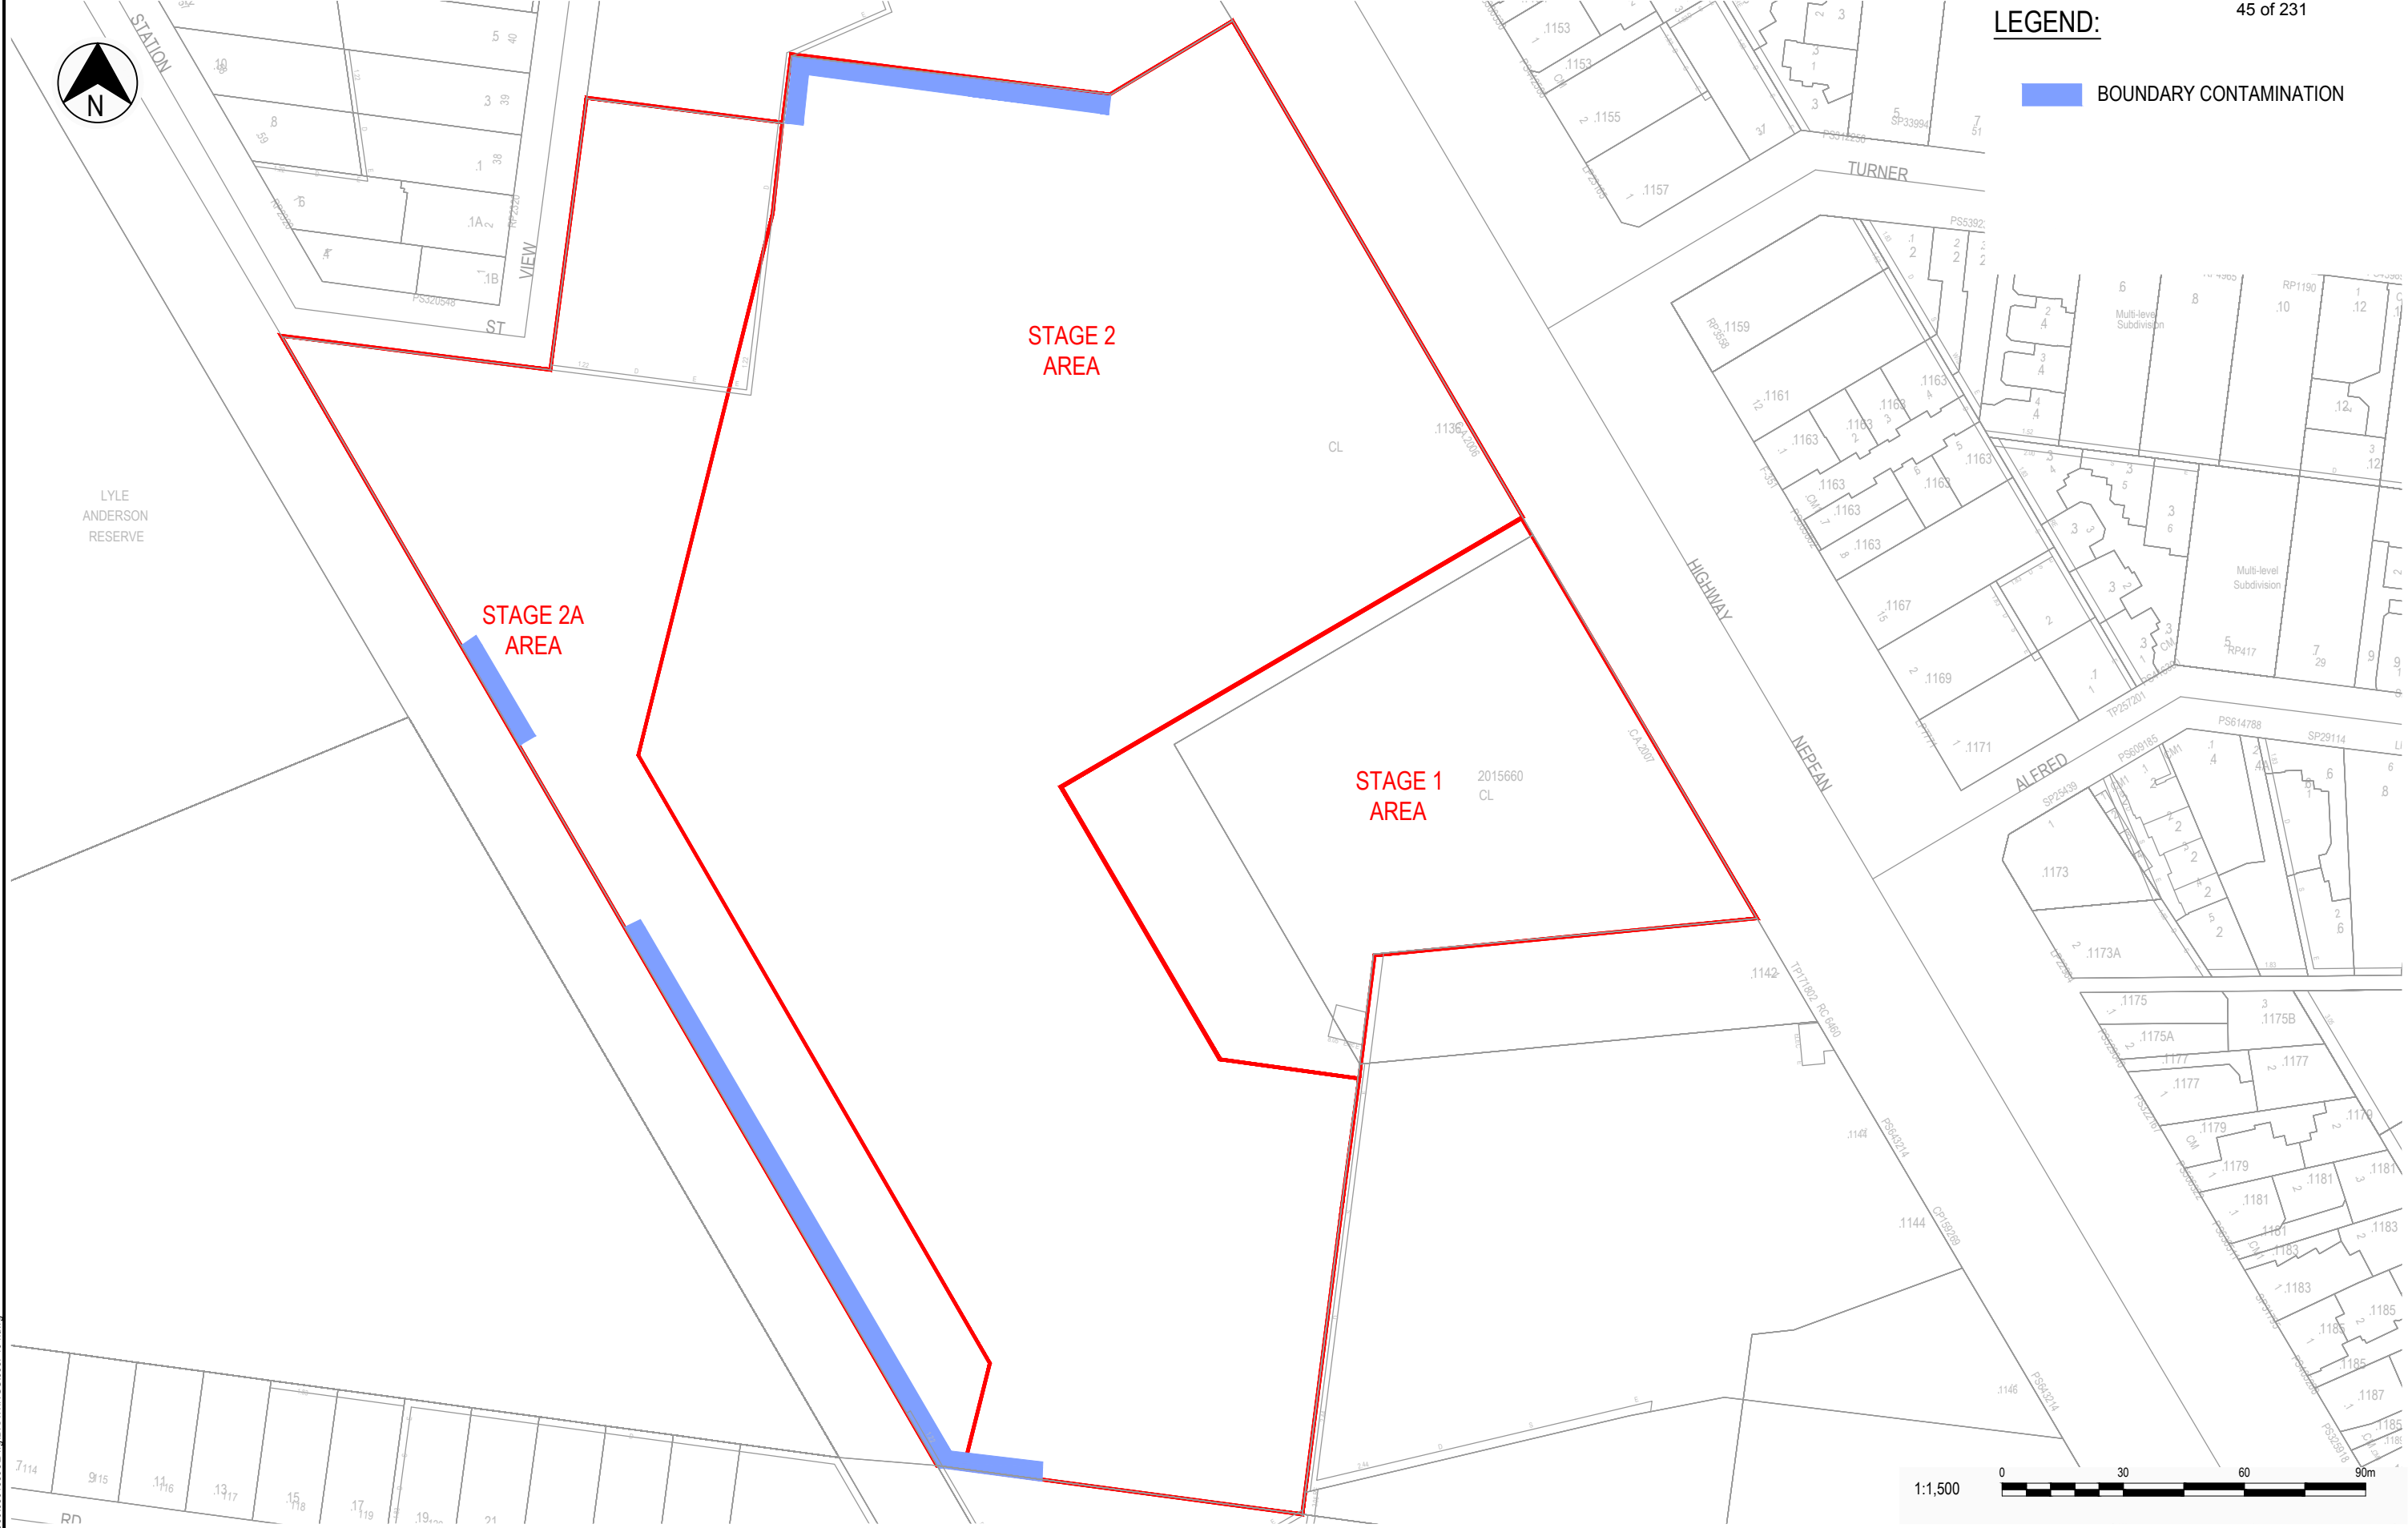
| FIGURE No | FIGURE 1 |

This Groundwater Quality Management Plan (GQMP) has been prepared for implementation in the Stage 2 and 2A areas of the Former Highett Gasworks located at 1138 Nepean Highway, Highett (the site") (refer Figure 1).

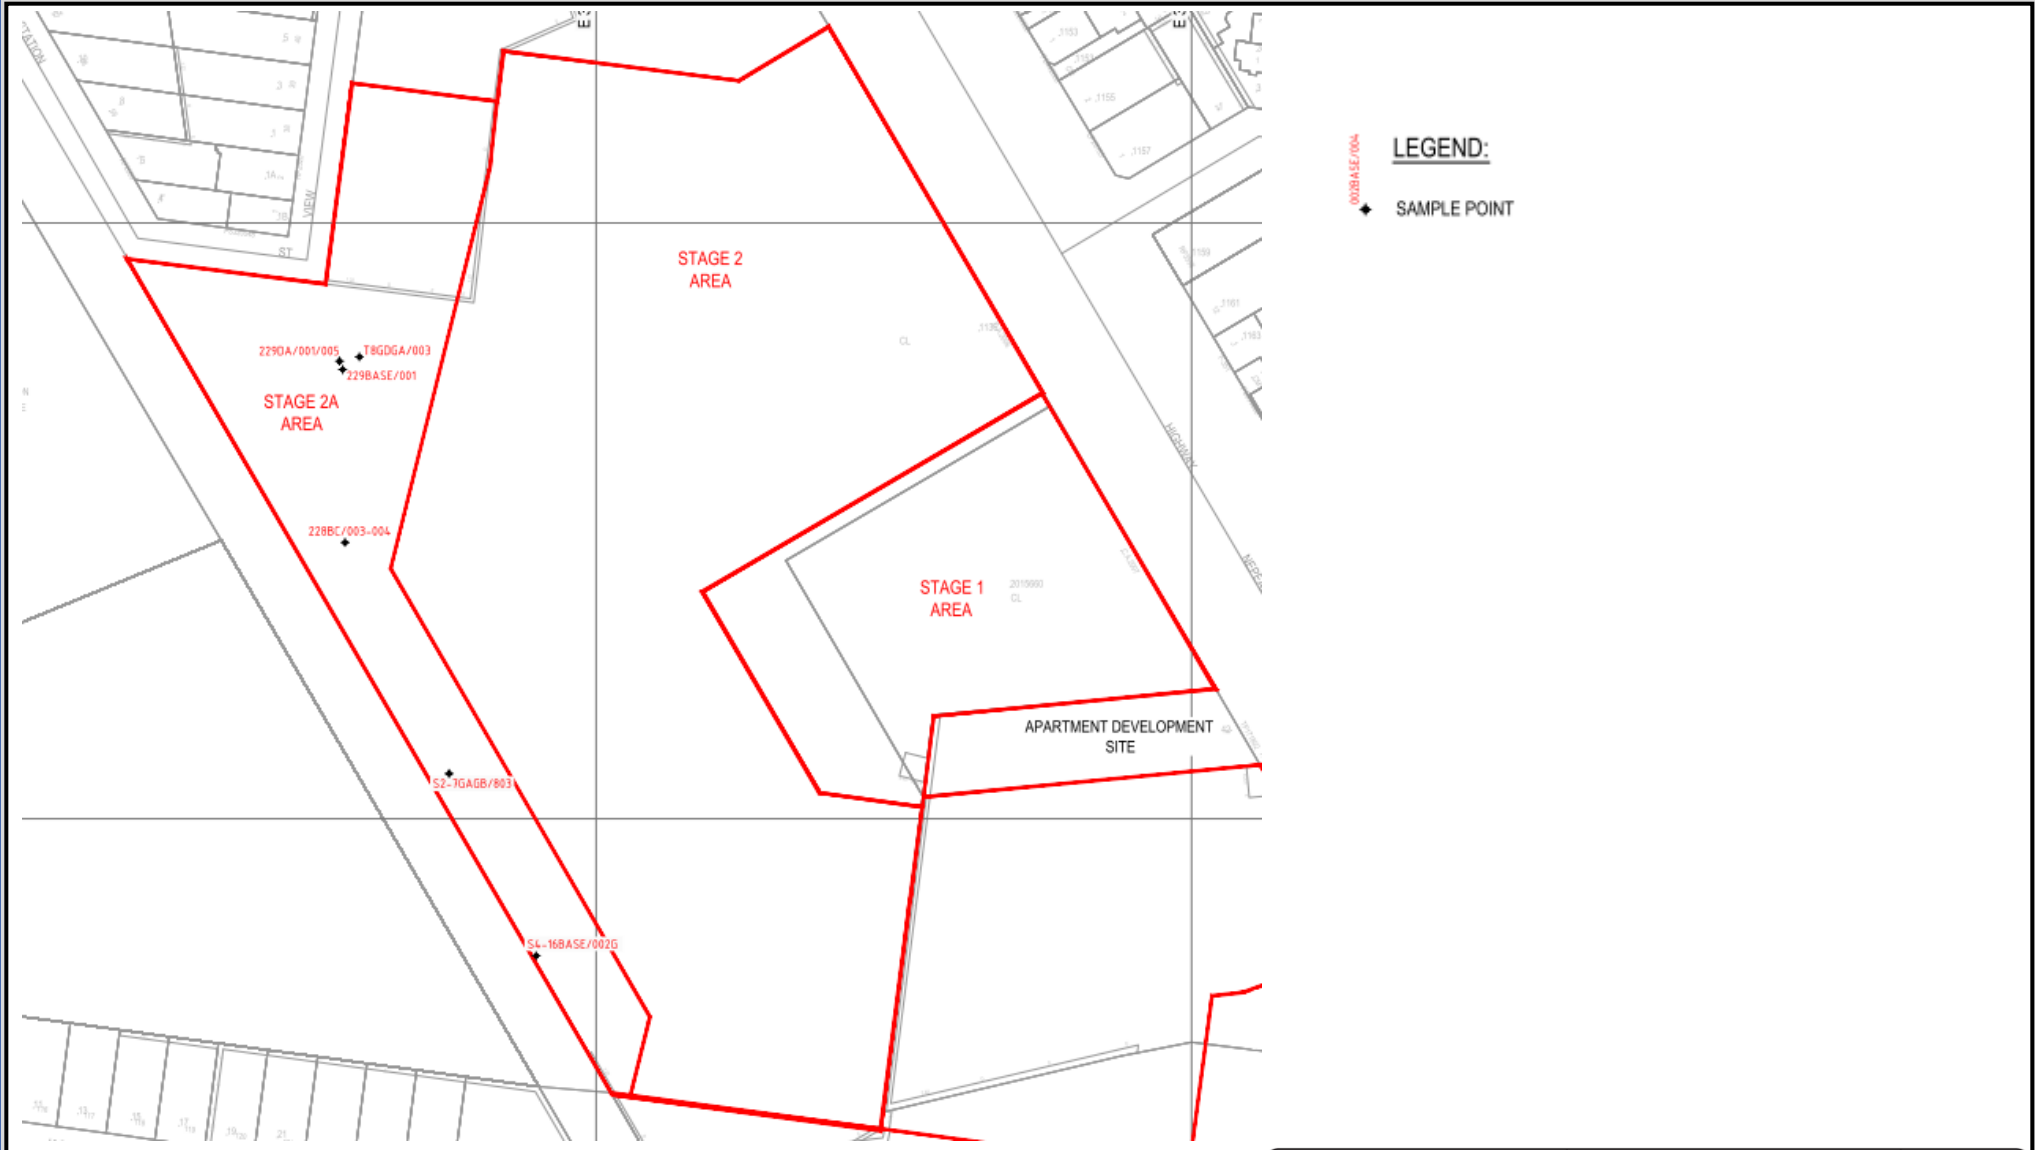
Figure 26 – Residual soil posing potential vapour risk to residential site users

The residual contamination in the vicinity of the gas main on Stage 2A represented by the concentrations in excavations 228, 229, S2-7, S4-16, and T8 pose an unacceptable vapour risk to residential receptors must be removed prior to residential redevelopment (**Figure 26, Appendix A**).
