# **ENVIRONMENTAL AUDIT REPORT**

**151-153 Church Street,  
Geelong West, Victoria**

**Vic EPA CARMS REF 68842-1**

**Prepared for  
Mobil Oil Australia Pty Ltd**

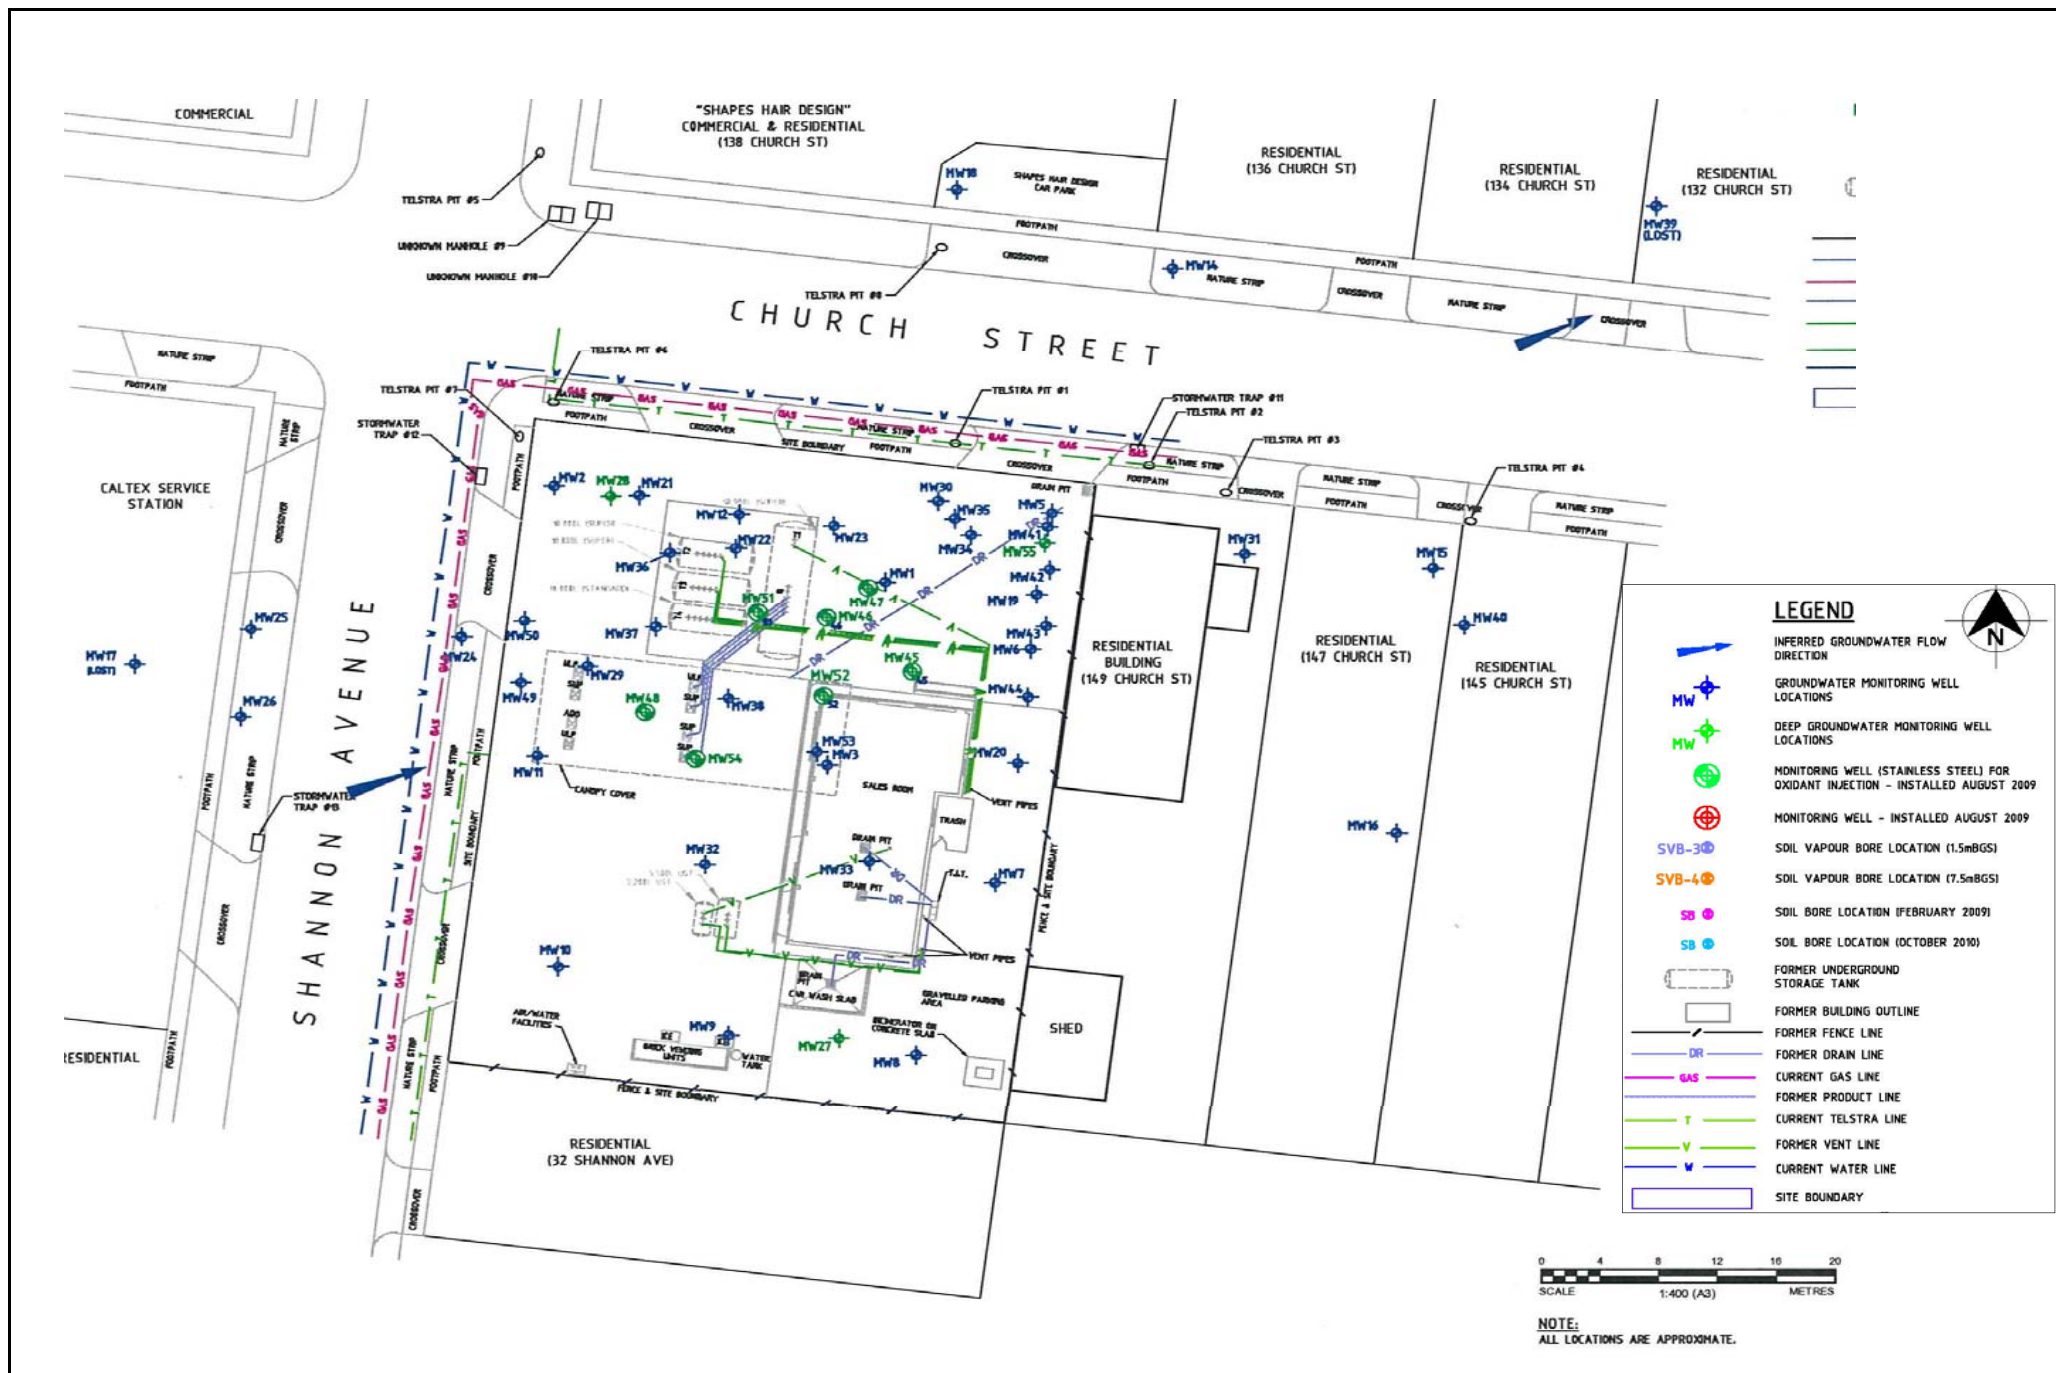
**Figure 3. Monitoring Wells & Soil Vapour Bore Locations**

A number of phases of soil and groundwater investigations have been completed since 1997. A network of groundwater monitoring wells has been progressively established on-site, and off-site in adjoining properties and road reserves to delineate groundwater impacts and monitor conditions over time (refer plan provided as Figure 3).

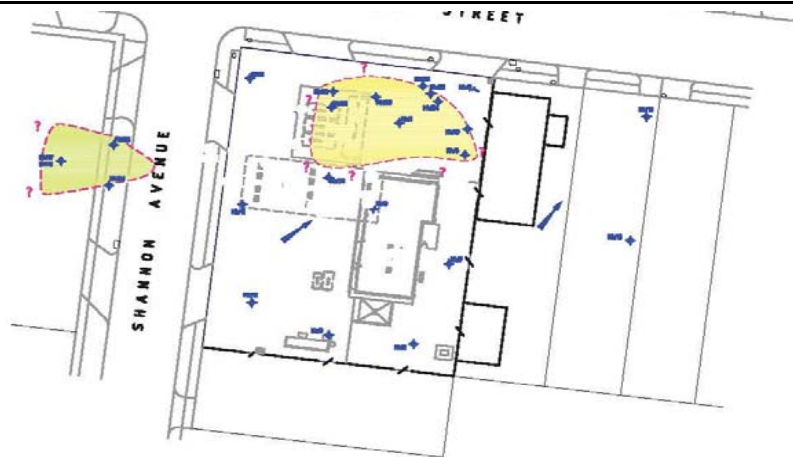
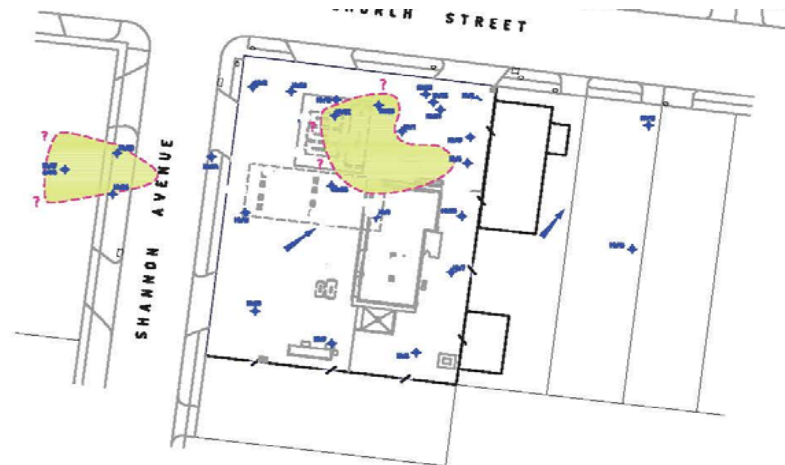
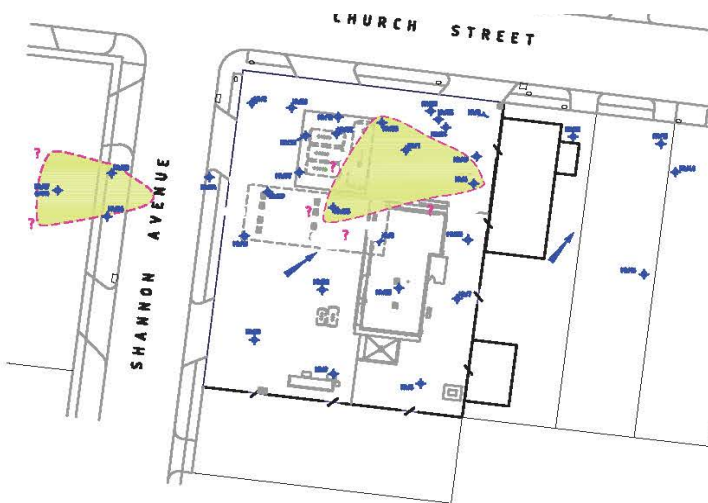
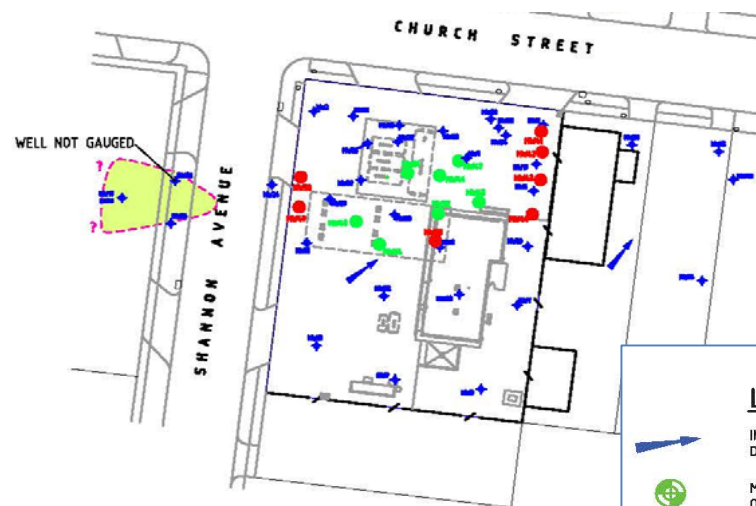
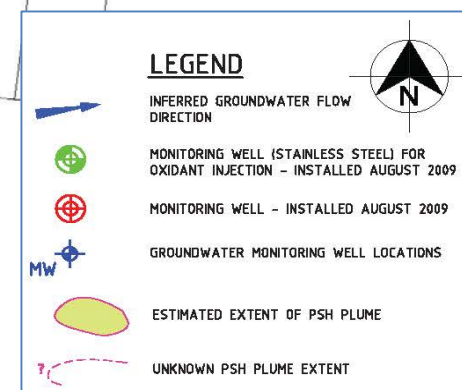
**Figure 8. Interpreted Historical NAPL Extent**

**INFERRED PSH PLUME OCTOBER 1998**  
CONDUCTED BY HANDEX

**INFERRED PSH PLUME JUNE 2003**  
CONDUCTED BY COFFEY (IT Environmental)

**INFERRED PSH PLUME FEBRUARY 2009**

**INFERRED PSH PLUME JANUARY 2011**  
NO MEASURABLE PSH

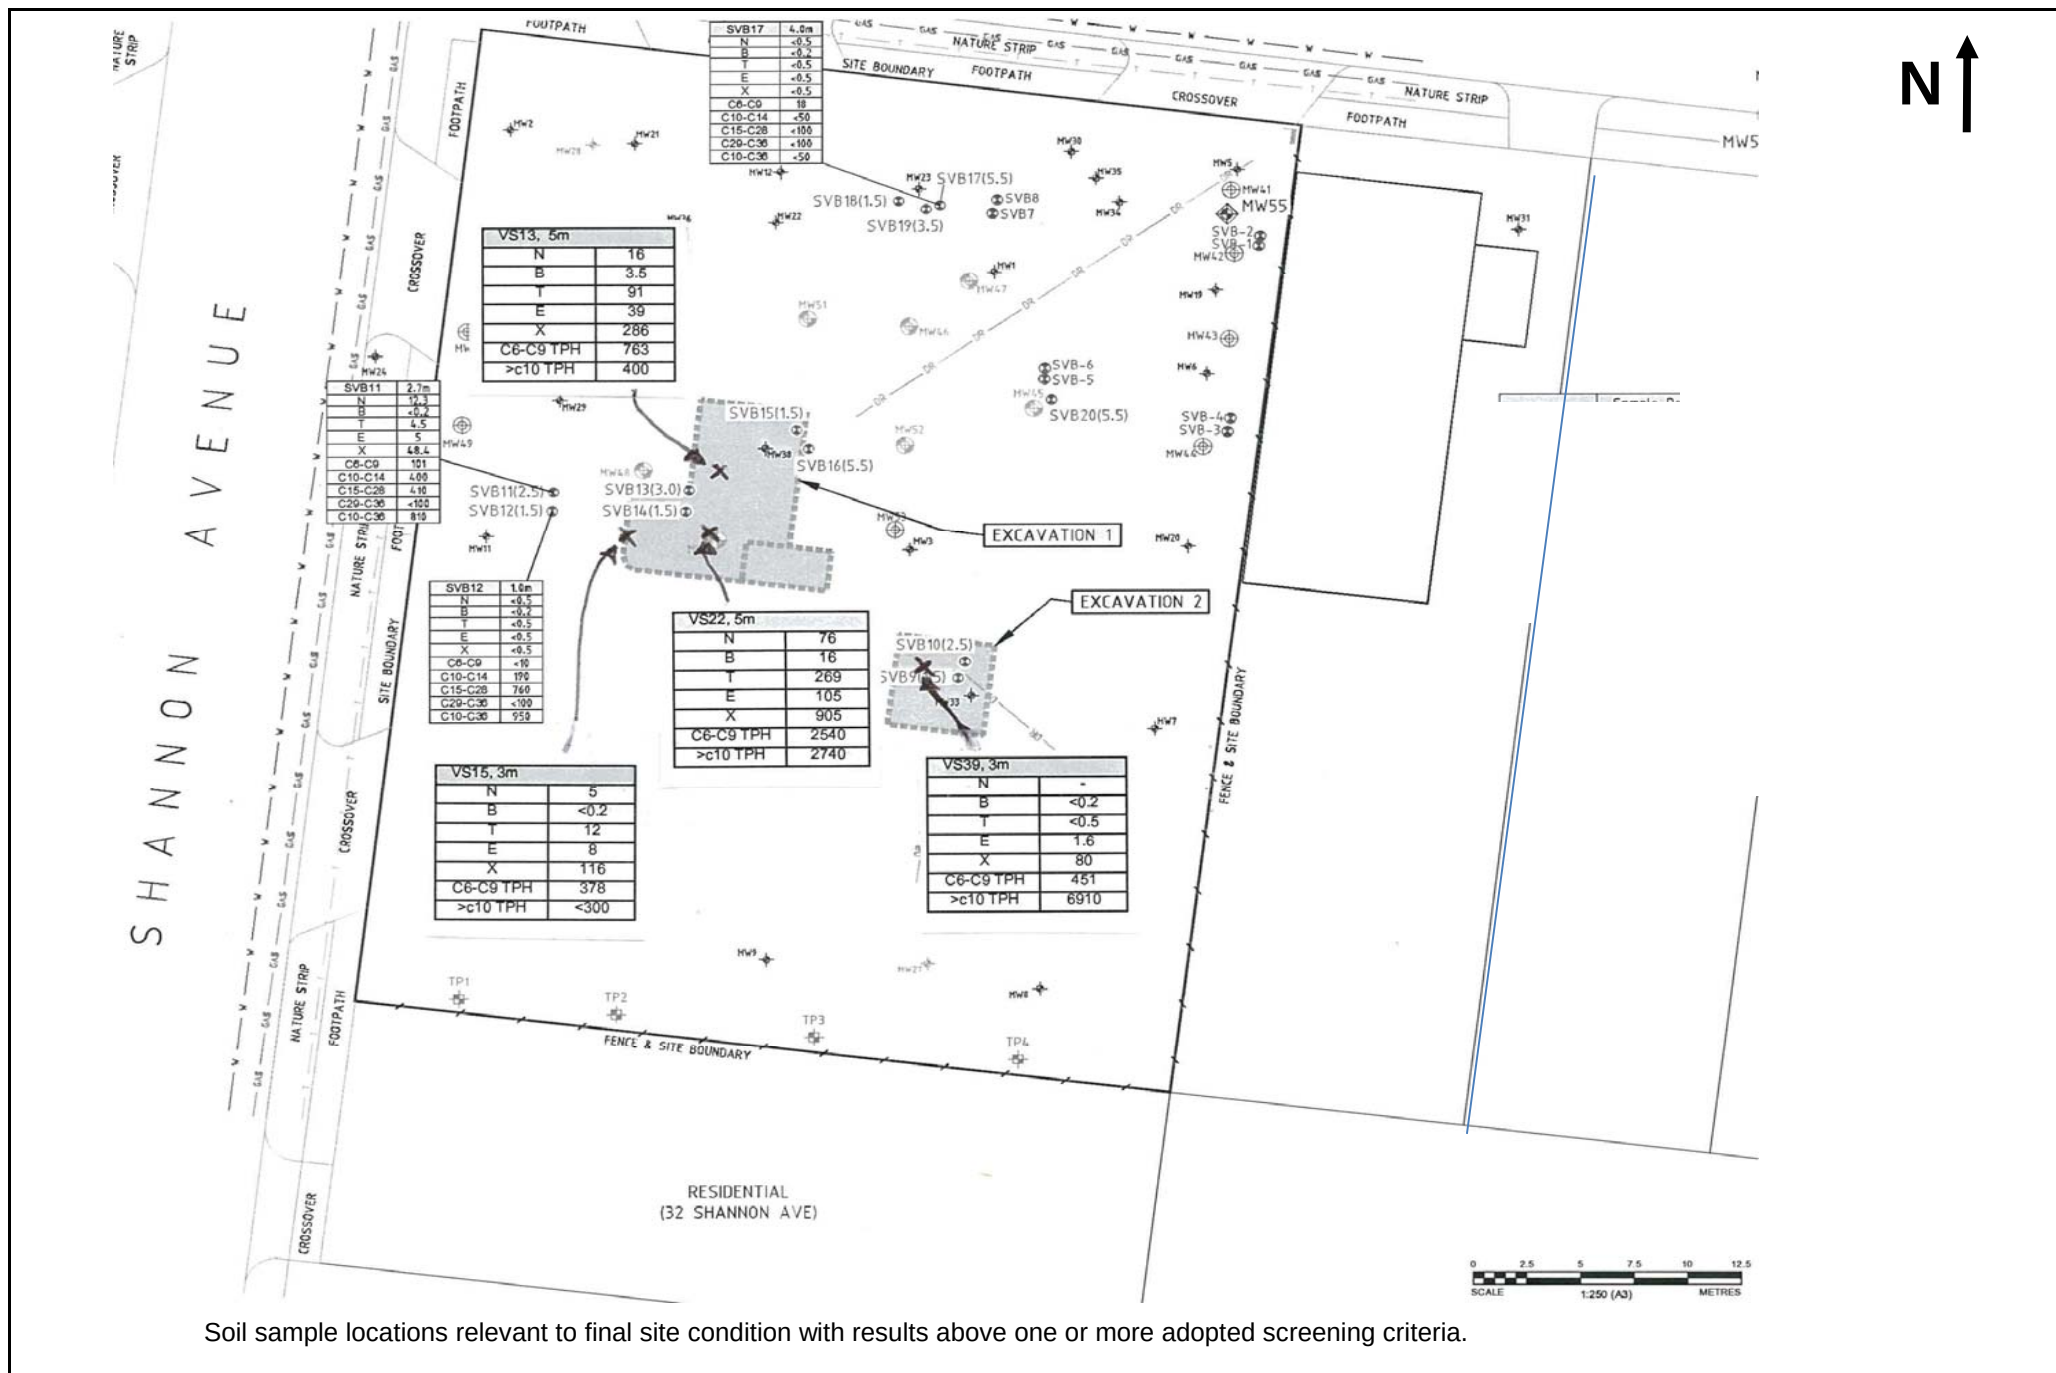
**Figure 9. Residual Soil Impacts**

Soil sample locations relevant to final site condition with results above one or more adopted screening criteria.

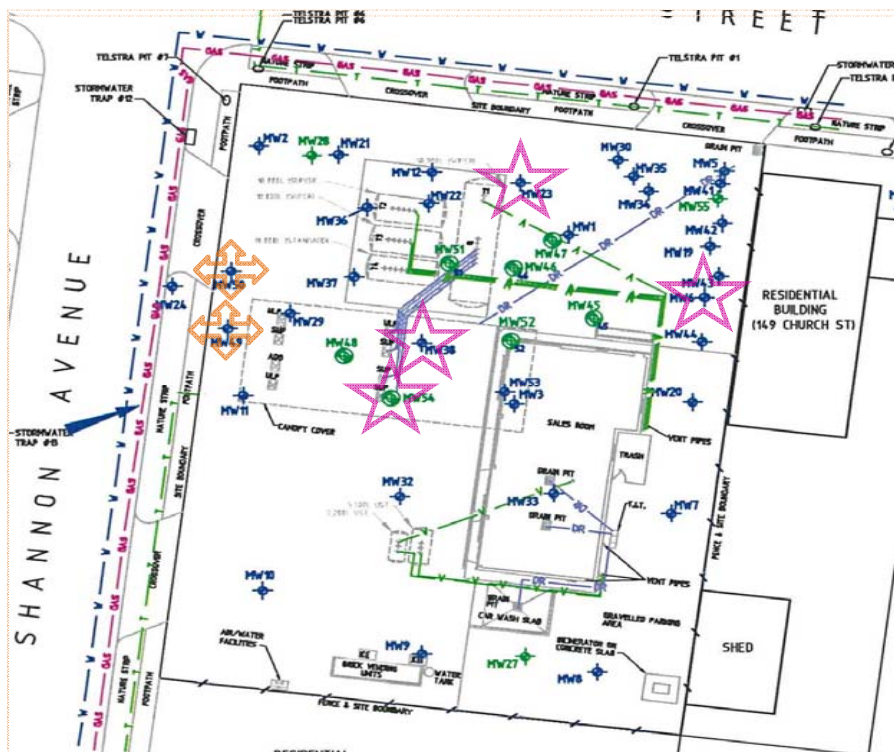
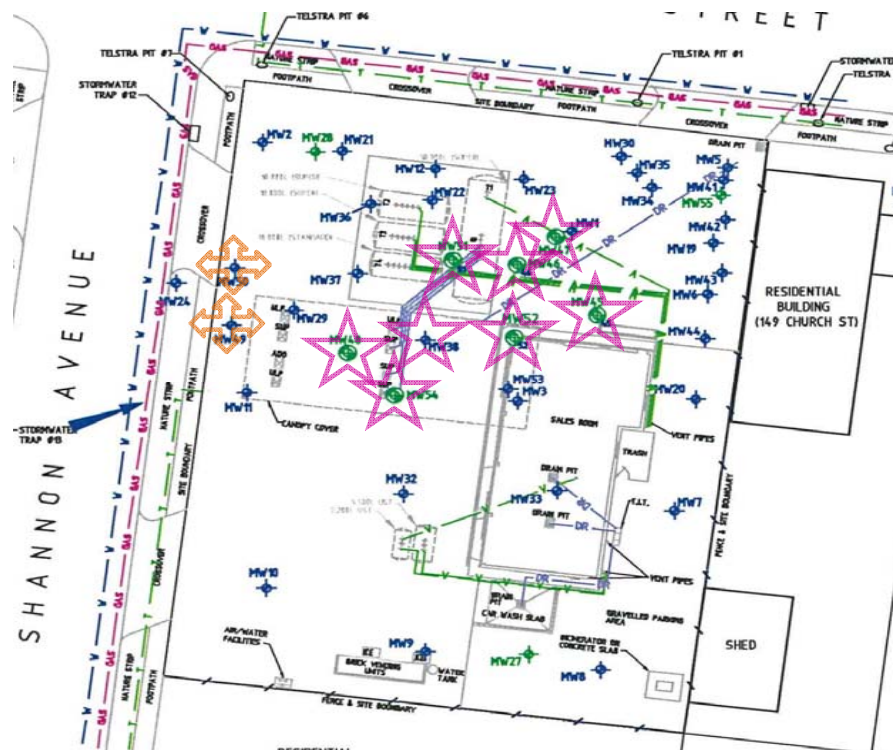
## SEPTEMBER 2009 (ORA INJECTION AND MPEAT)

## MARCH 2010 (ORA INJECTION AND MPEAT)

Oxygen release agent (ORA) injection locations.  
(total 4,750L of ORA injected)

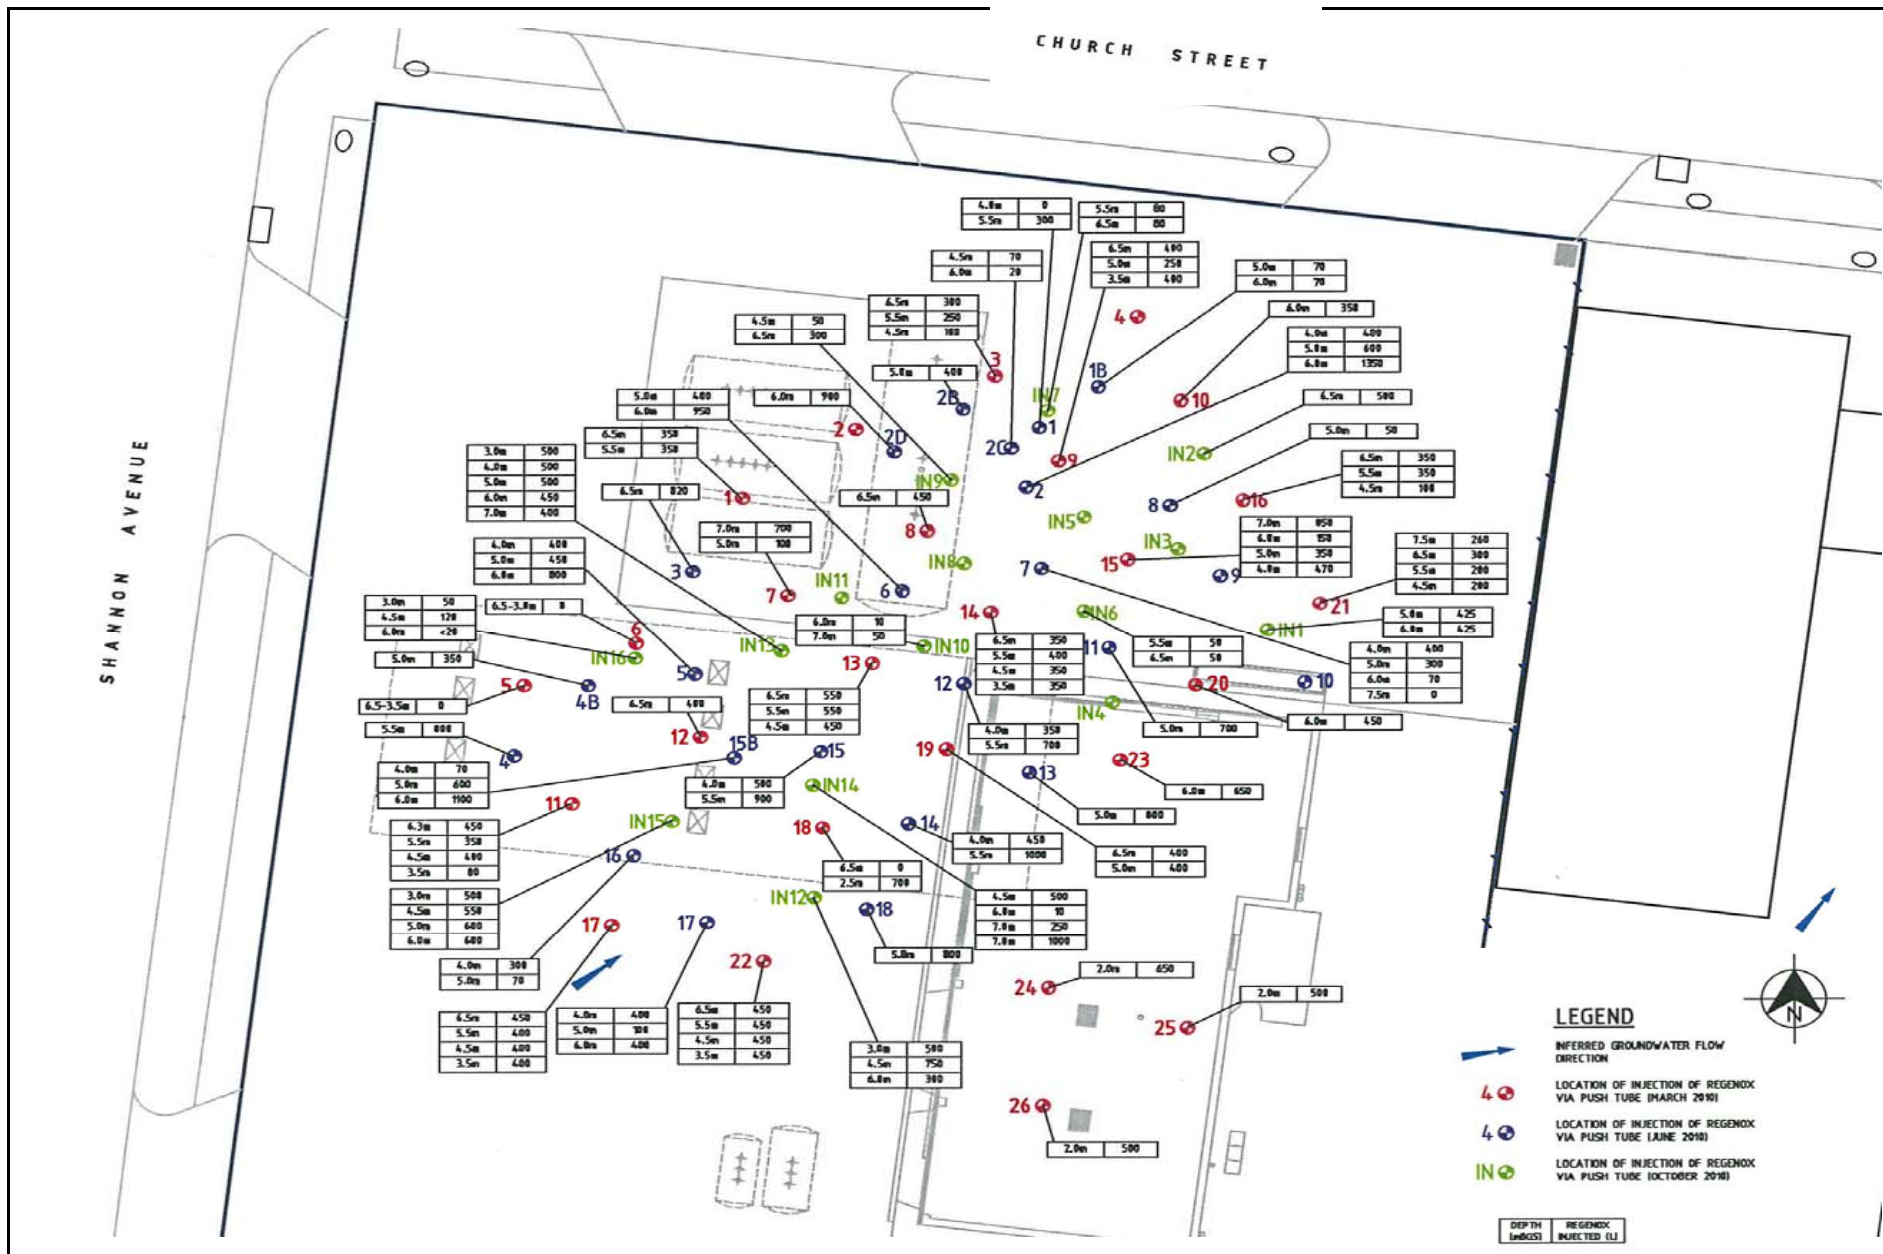
**Figure 11. ISCO Injection Locations in Soil (2010)**

Coffey Environments subsequently conducted three rounds of in-situ chemical oxidation (ISCO) between March and November 2010. The program comprised three rounds of sequential soil and groundwater injections of RegenOx. Coffey noted in the CUTEP Report that RegenOx was selected is the ISCO agent in order to limit the risk of surfacing incidents in the proximity of neighboring properties, as it is not as reactive as some other alternative ISCO agents and it was thought the process would be able to be better controlled. During each round, RegenOx was injected via direct push tube into soils at various depth intervals targeting hydrocarbon impacts in soils from just above the existing water table level and upwards into the inferred smear zone that has been created by historical groundwater water level fluctuations. Each round of soil injection was followed by a round of multiphase vacuum extraction (MPVE) and injection of RegenOx in selected groundwater bores. The objective of the follow up injection and MPVE was to control the reactivity of the Region being injected whilst also further mobilizing hydrocarbons from the overlying smear zone and drawing these into the saturated zone where they could be extracted via MPVE. Coffey have reported that a total of 5,625kg of RegenOx was injected into the subsurface over the three events. Coffey reported that the injections into soil had no significant influence on groundwater levels in neighboring wells, which suggested the injected fluids were being successfully distributed in the formation above the water table. Figure 11 attached shows the soil injection locations, whilst Figure 12 shows the groundwater injection locations.
