Flametree Property Pty Ltd

Preliminary Risk Screen Assessment

Site at 51A Douglas Street, Noble Park Victoria 3174

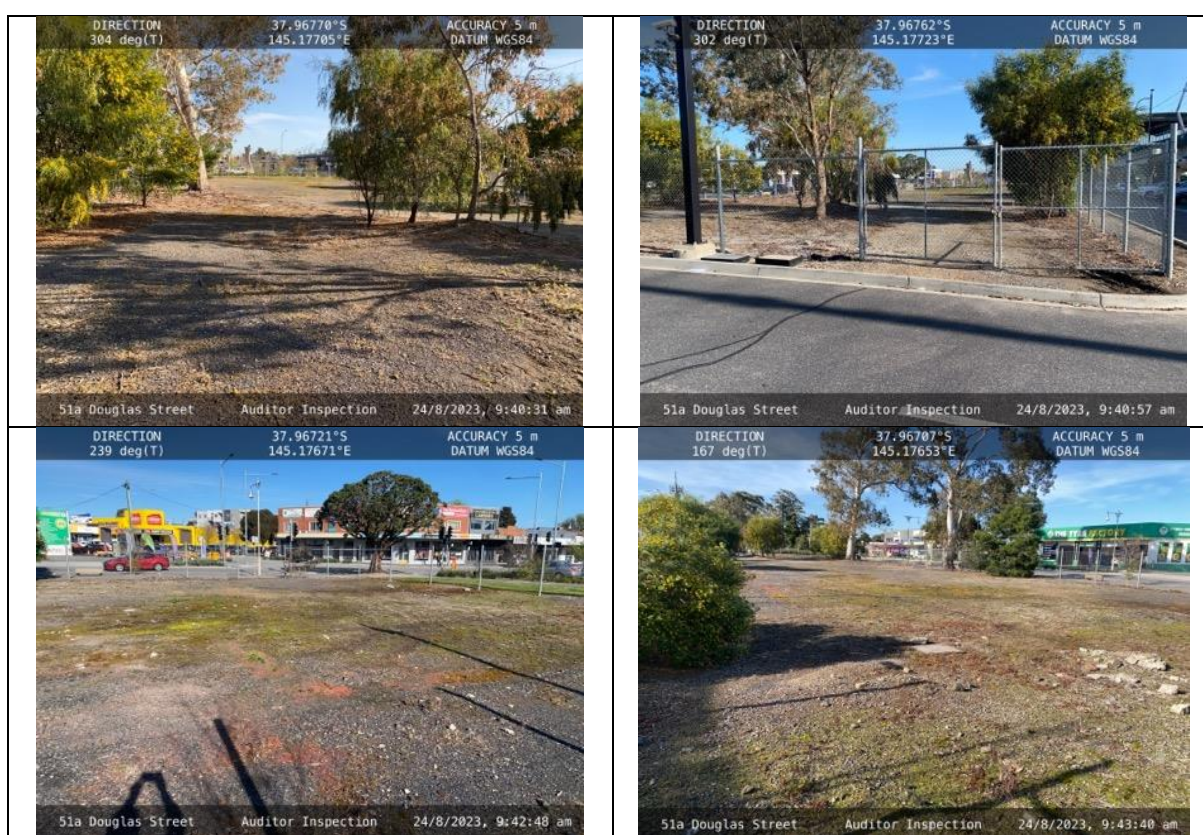
Plate 4-1 – Typical Site Conditions

The overall development site is currently vacant. The site is generally flat and slopes slightly down towards the north with an elevation of approximately 34 mAHd (Lotsearch, 2023).

The inspections by the Auditor of the overall development site revealed no visible evidence that the site has been filled in the past; existing ground levels are consistent with surrounding natural ground. No waste materials or stockpiles of soil were observed on the site.

There was no evidence of observed during the site inspection of stained or odorous soil or distressed vegetation.
