Report on  
Preliminary Risk Screen Assessment

Site Redevelopment  
2-6 Thompson Road, North Geelong

Prepared for  
DUN-RA Investments Pty Ltd

Project : 215419.00  
R.001.Rev0  
30 August 2022

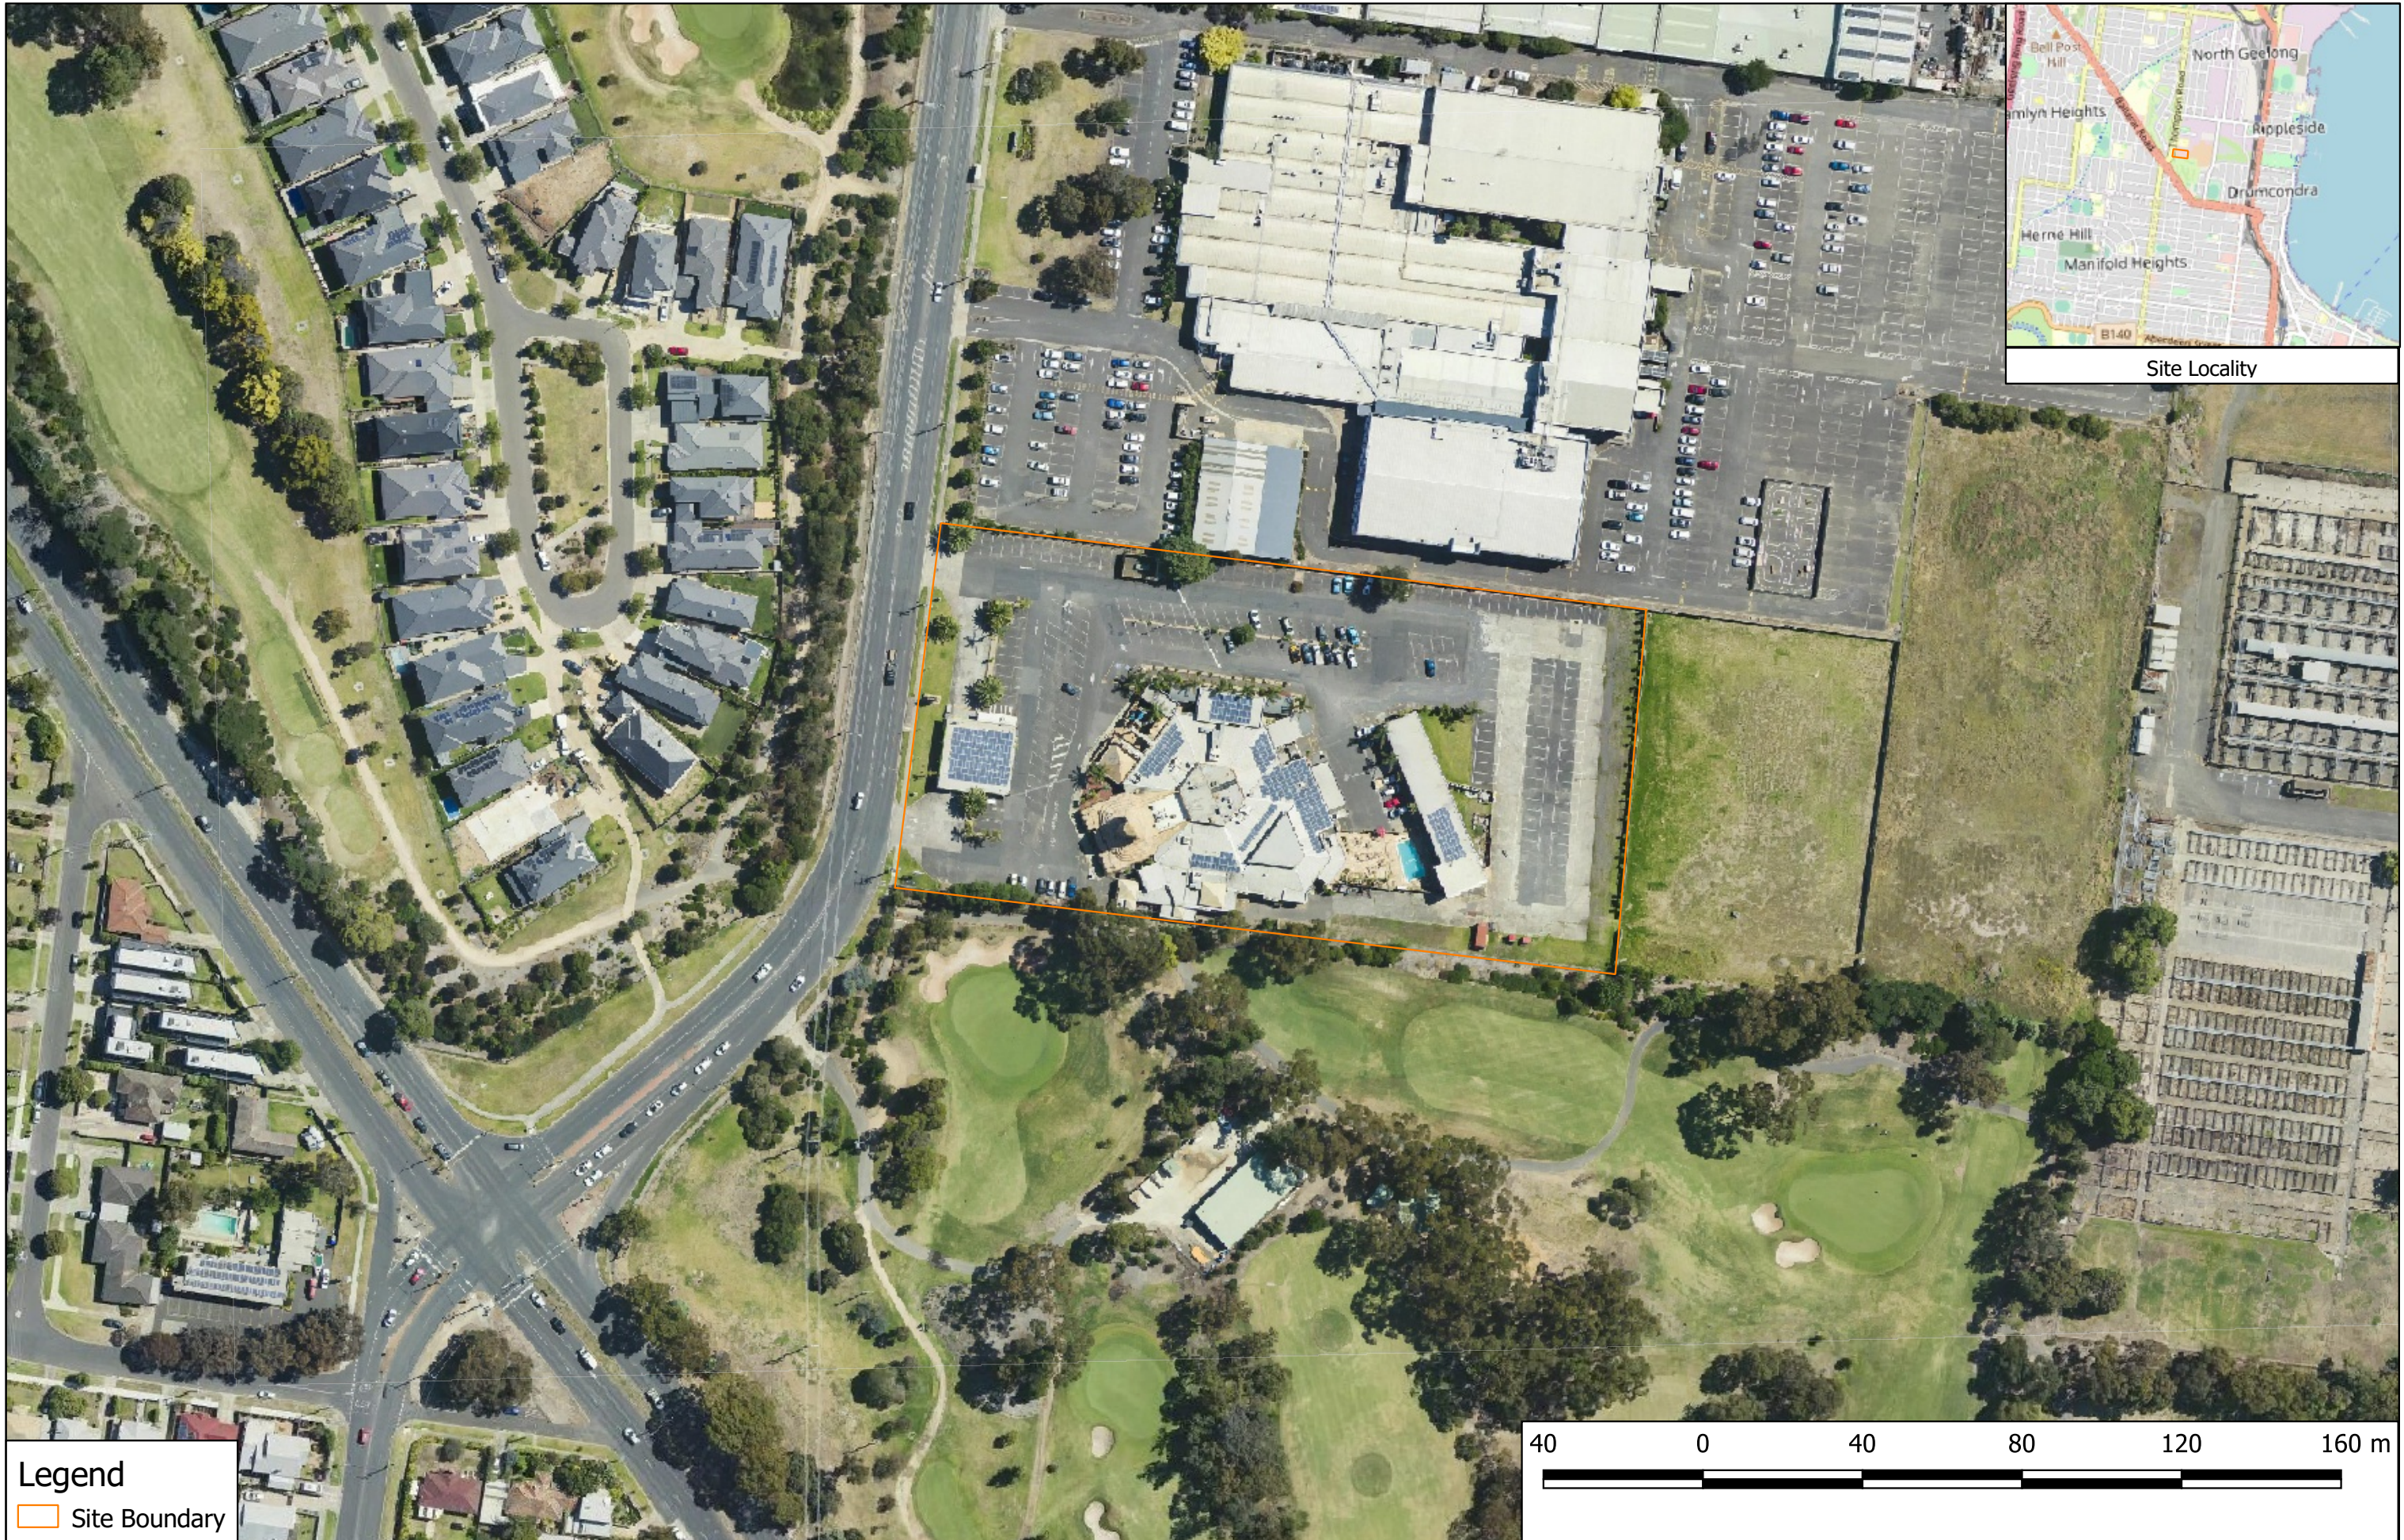
PROJ. #: 215419.00  
DRAWING No: 1  
REVISION: 0

The site subject to the PRSA is located at 2-6 Thompson Road, North Geelong, Victoria, shown in Drawing 1 Appendix B. Site identifying information and PRSA details are summarised as follows:

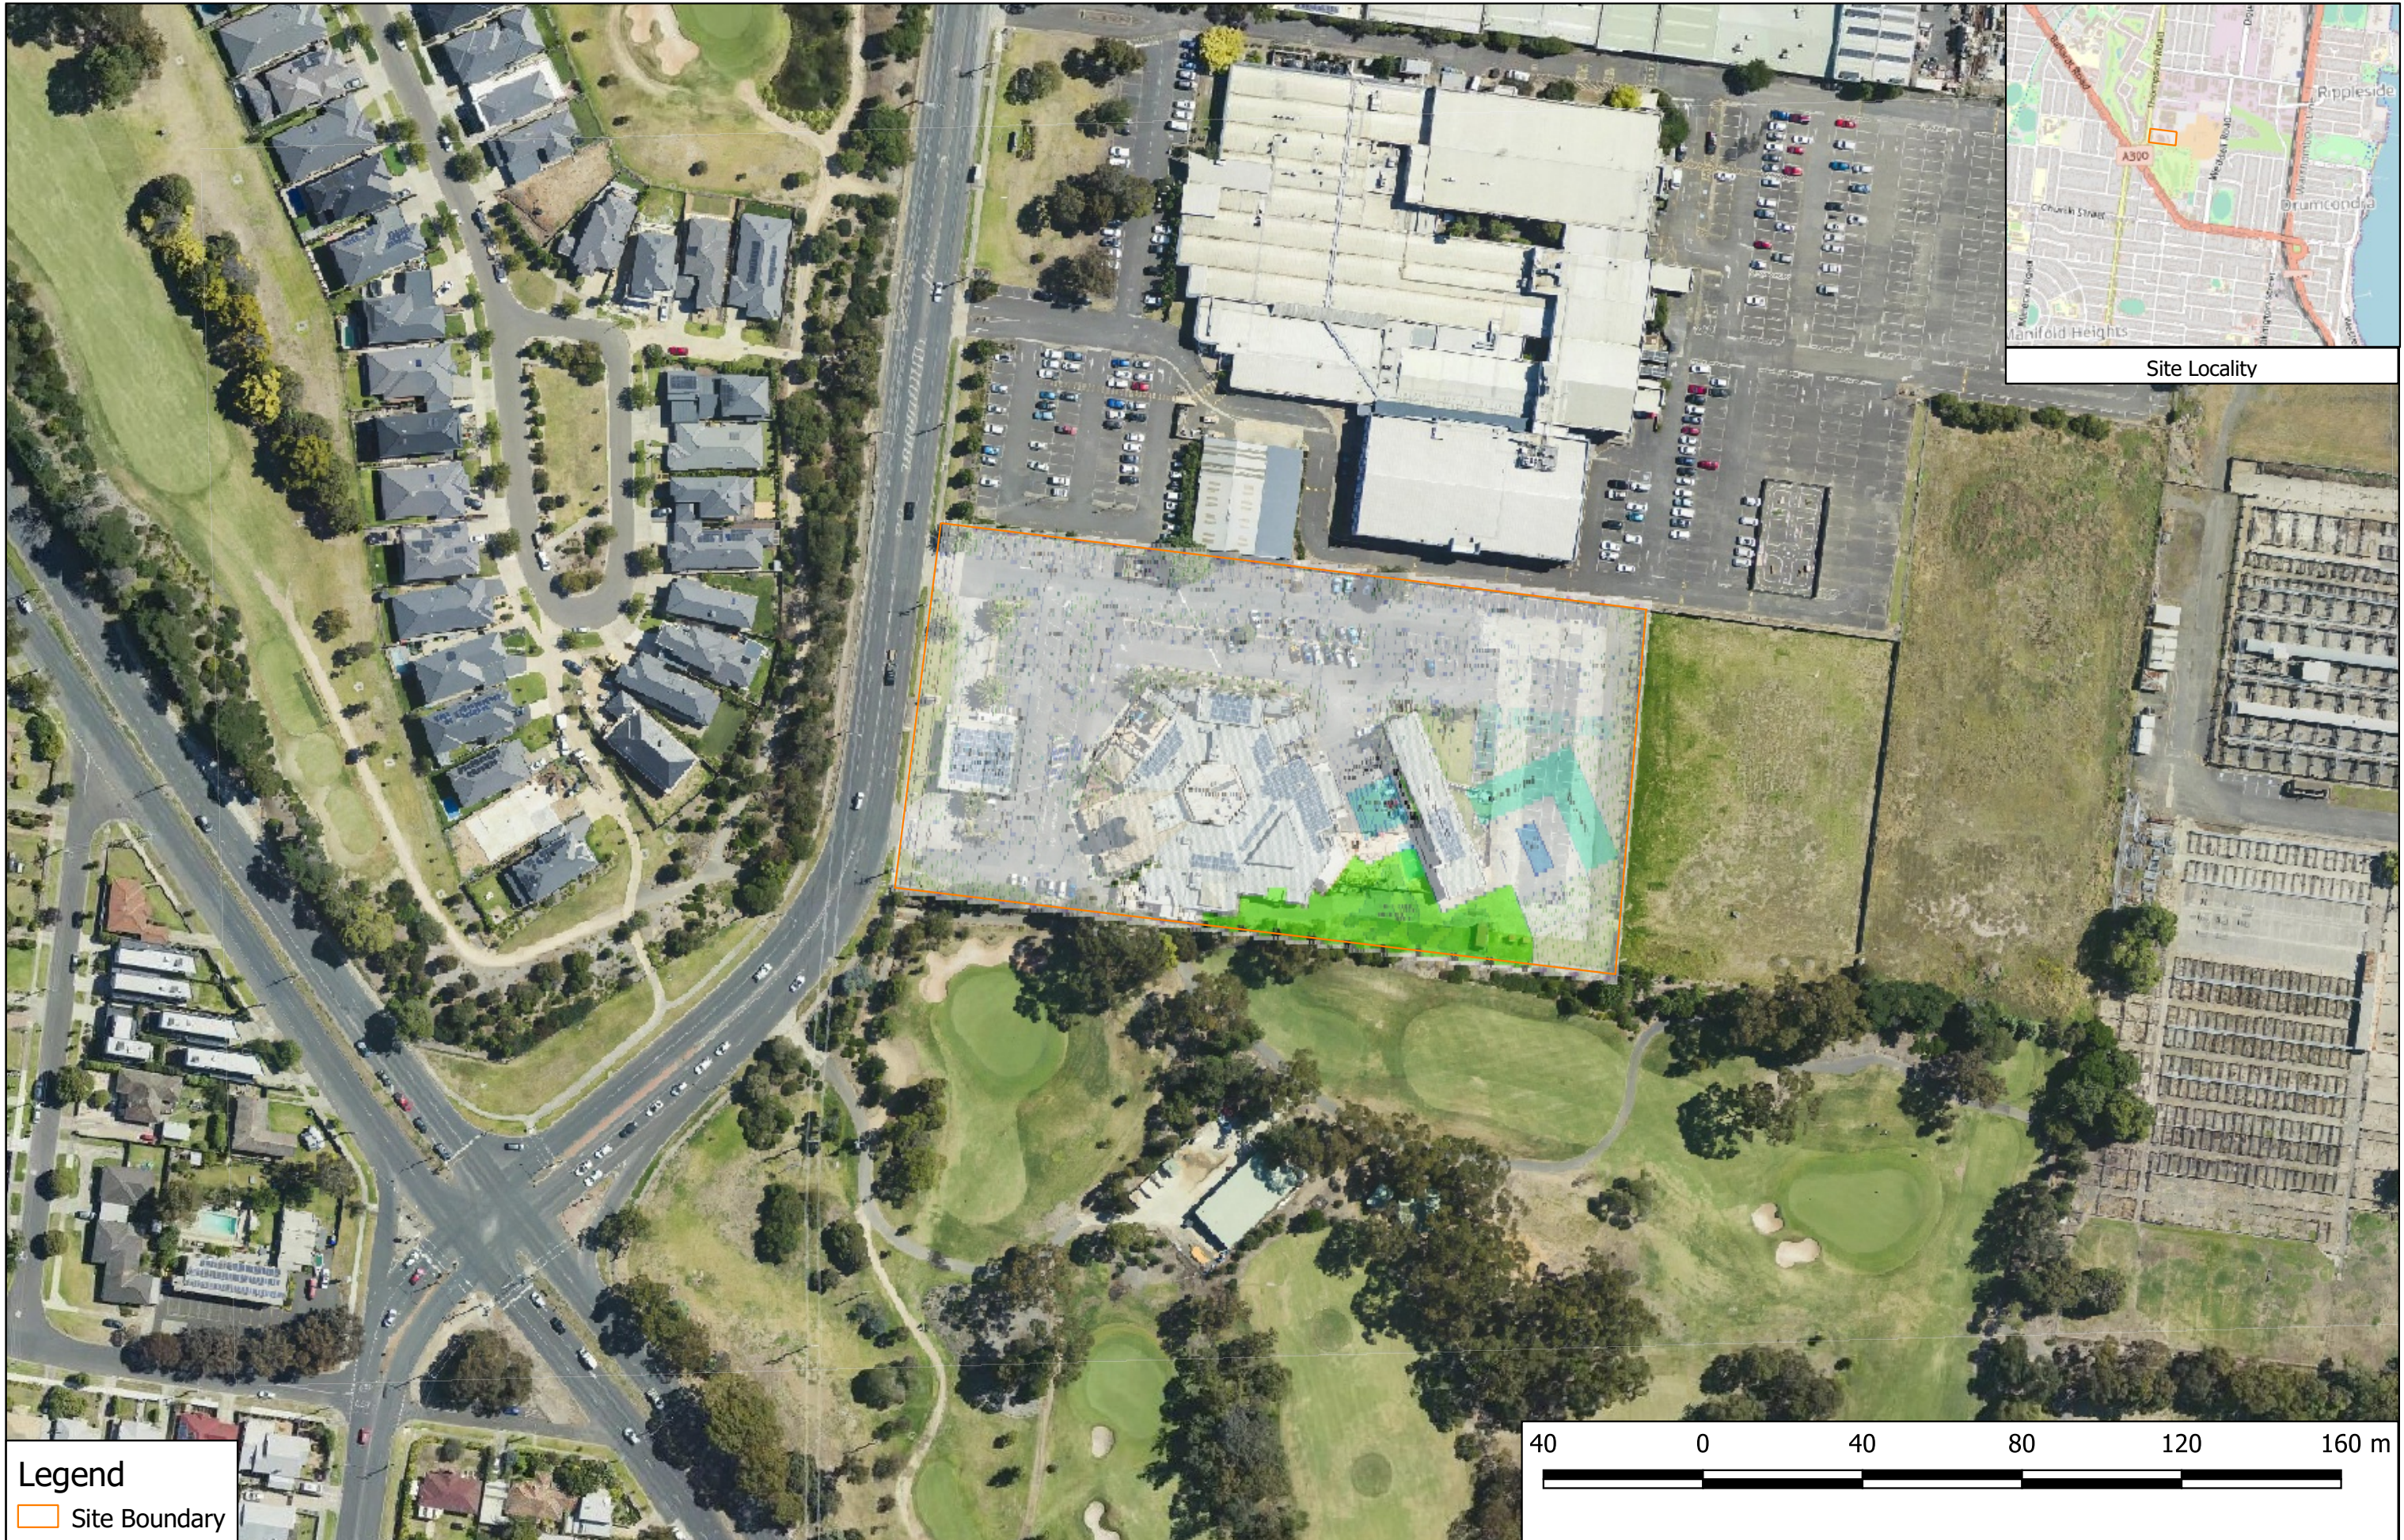
| DRAWING No: 2 |

| Item | Information |
|---|---|
| Plan of site/ premises/ location showing the PRSA site boundary attached | Drawing 2, Appendix B |

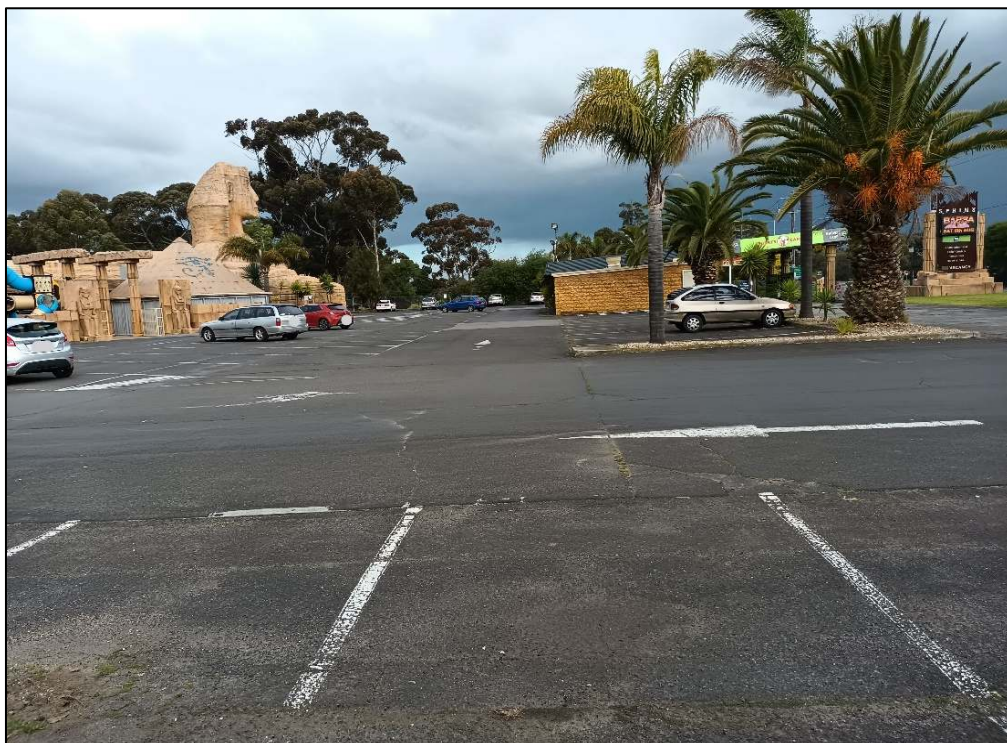
On the date of the inspection (5 August 2022), the Auditor's assistant observed that the site was currently operating as a hotel and motel, with a drive-through liquor shop at the front of the site. There was asphalted carparking in mostly good condition, and some vegetated, mulched garden beds on the site. Two driveways were present on the western boundary of the site, and the eastern side of the site was bounded by a fence. The site was relatively level with surface water drainage infrastructure observed on site.

Photo 1: General view of the western section of site, looking towards the south.

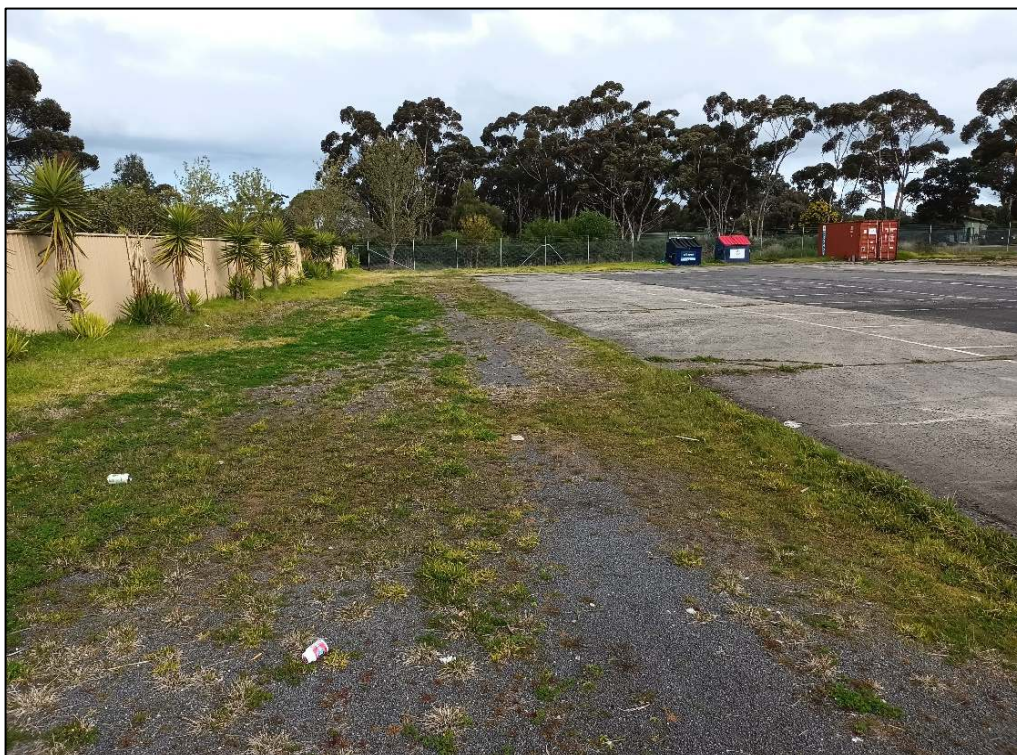
Photo 2: Eastern section of site, looking towards the south.

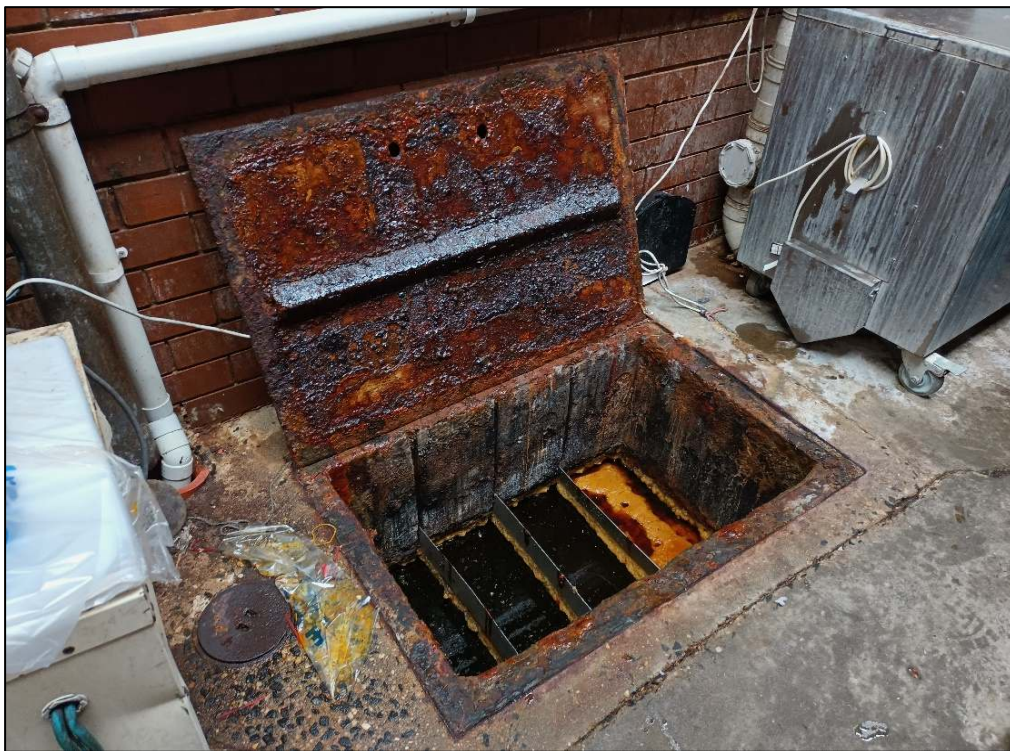
Inside the hotel and gaming area, a grease trap was observed to be in good working condition, with no leaks observed. A storage room for cleaning products, was also observed, no spills were noticed, and the concrete pad floor was observed to be in good working condition.

Photo 3: Grease trap observed in good condition behind kitchen.

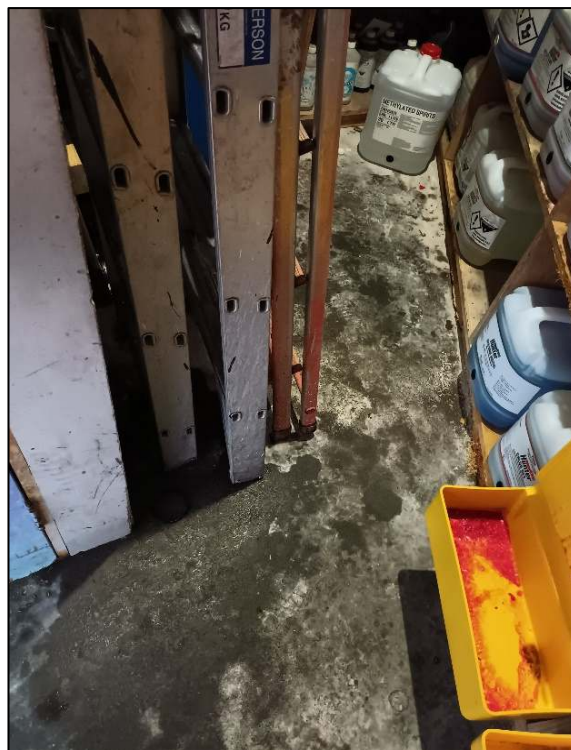
Photo 4: Floor of chemical storage room.

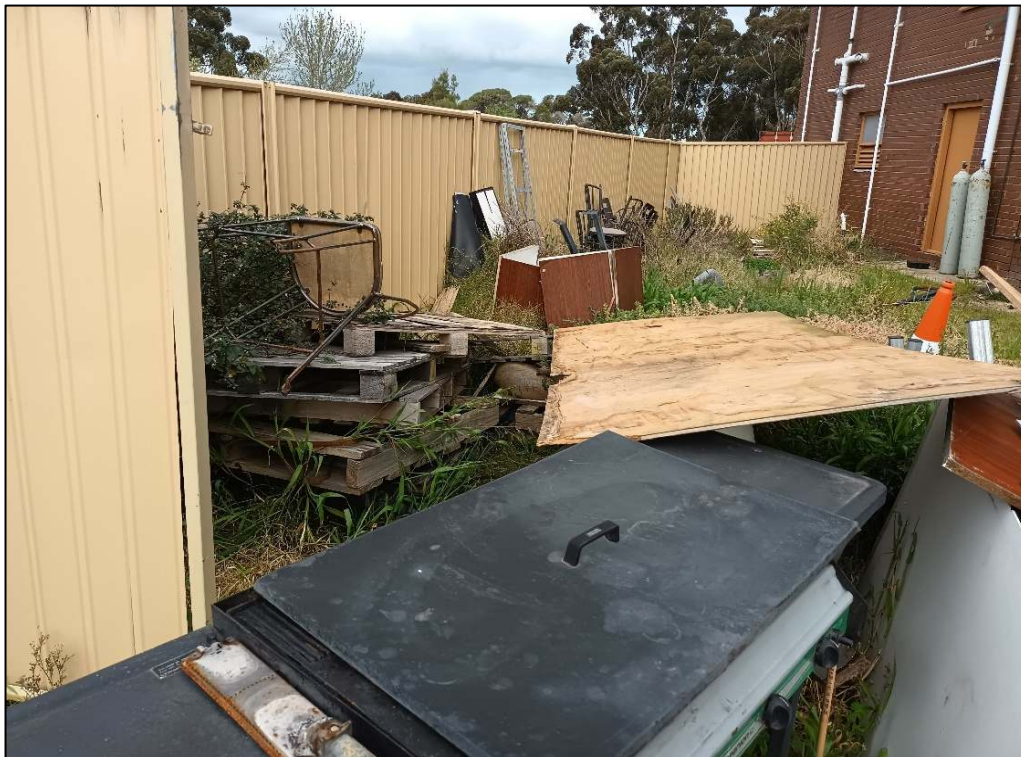
A small masonry fence structure on the north west of the site fences off a high voltage electrical switchbox/transformer. There were rubbish bins on the south eastern corner of the site and some stockpiling within the fence, east of the hotel rooms. The type of items observed in the stockpile include, fibreboard, doors, timber pallets, barbeque, steel tables and benches, planters, tables and chairs, dishwasher, and miscellaneous kitchen equipment. There were no signs of odorous or stained soils and vegetation appeared to be healthy.

Photo 5: Stockpiled items behind hotel rooms (south)

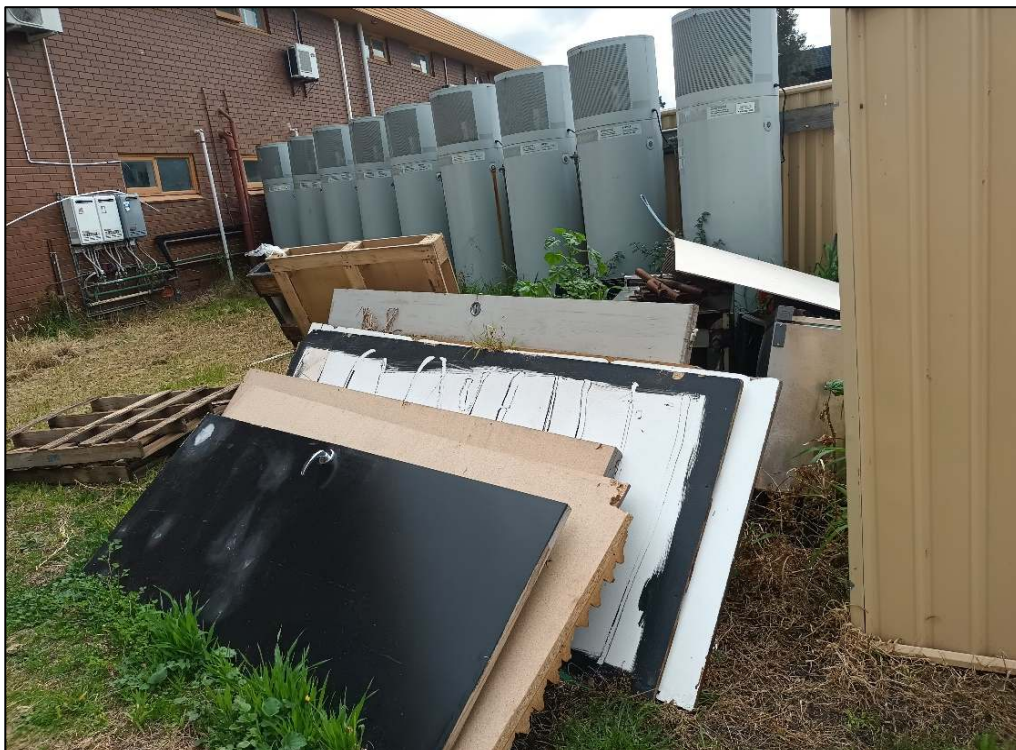
Photo 6: Stockpiled unused items behind hotel rooms (north)
