# Executive summary

Mr John Throssell, an environmental auditor (contaminated land) appointed under Division 1 of Part 8.3 of the *Environment Protection Act 1970* ("the auditor") of GHD was engaged by Department of Treasury and Finance (DTF) to conduct a section 53X audit of the Stage 2A portion of the former Highett Gasworks site located at 1136 – 1138 Nepean Highway, Highett Victoria. The audit site is shown in Figure 1.

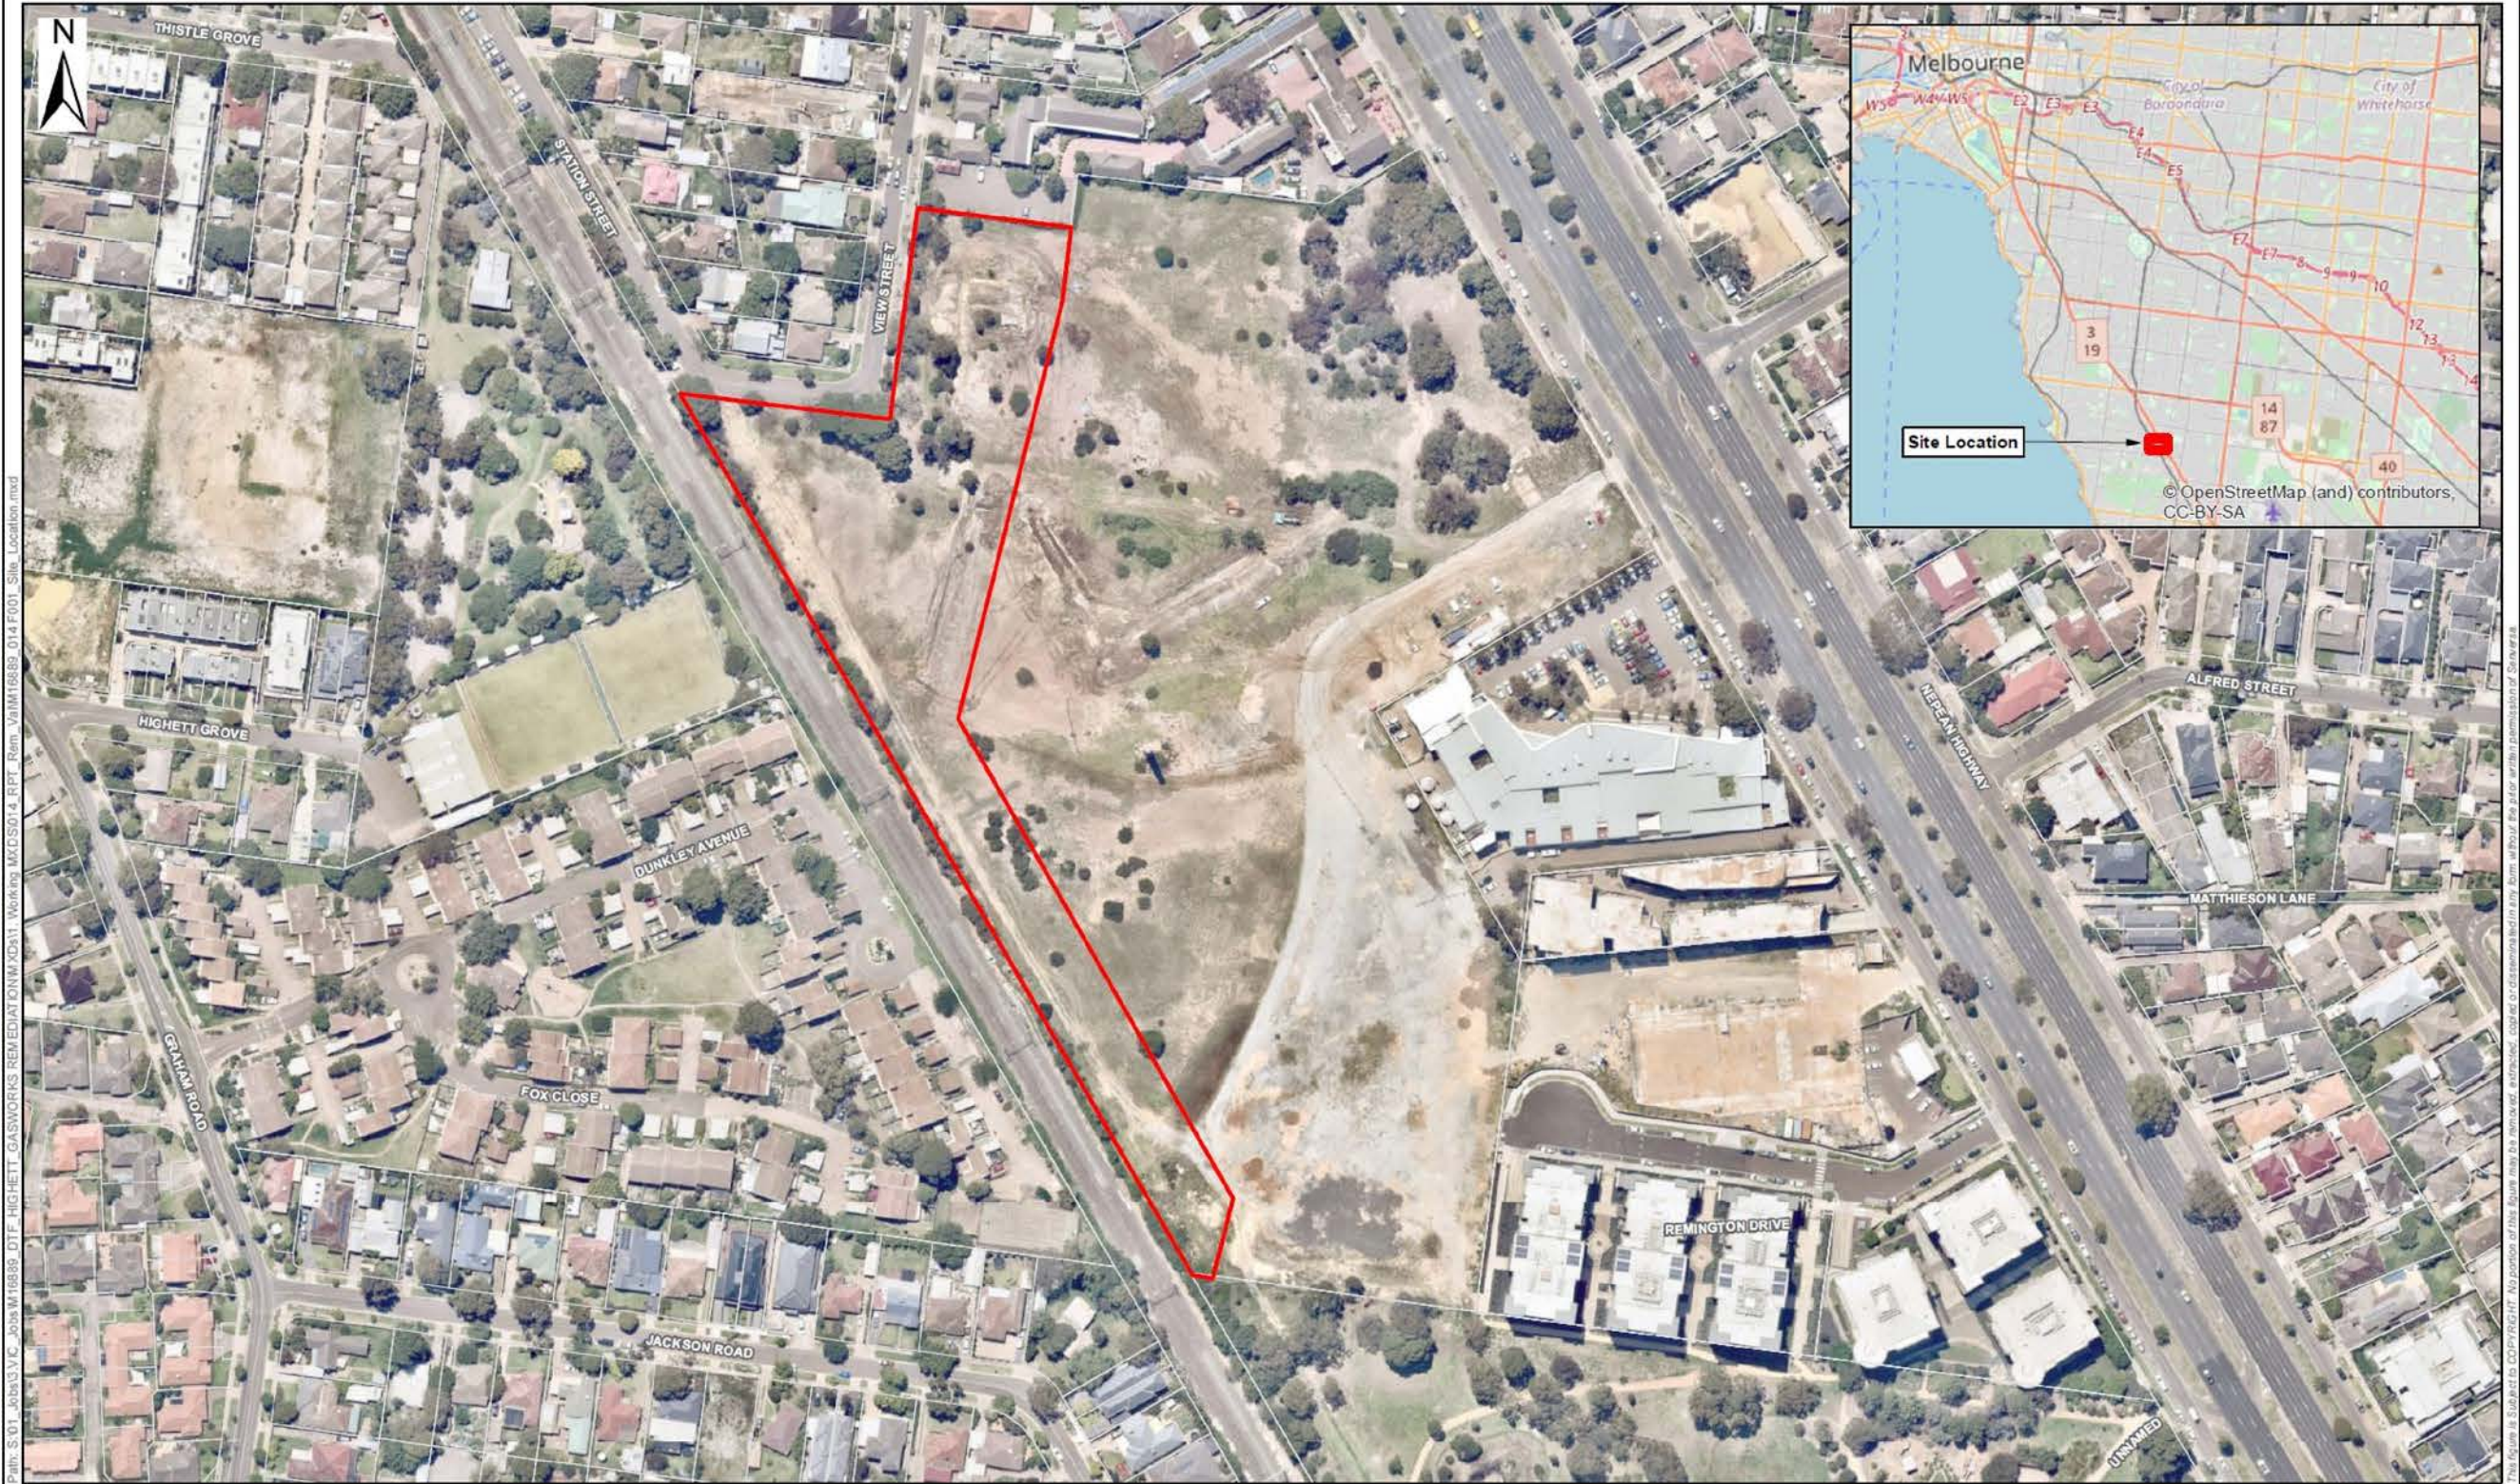
FIGURE 1

*Figure 1      Audit Boundary*

Source: Reproduced Figure 1 of Senversa Remediation and Validation 2021

| Summary information required | |
|---|---|
| Plan of site/premises showing audit boundary attached | Refer to Figure 1 |

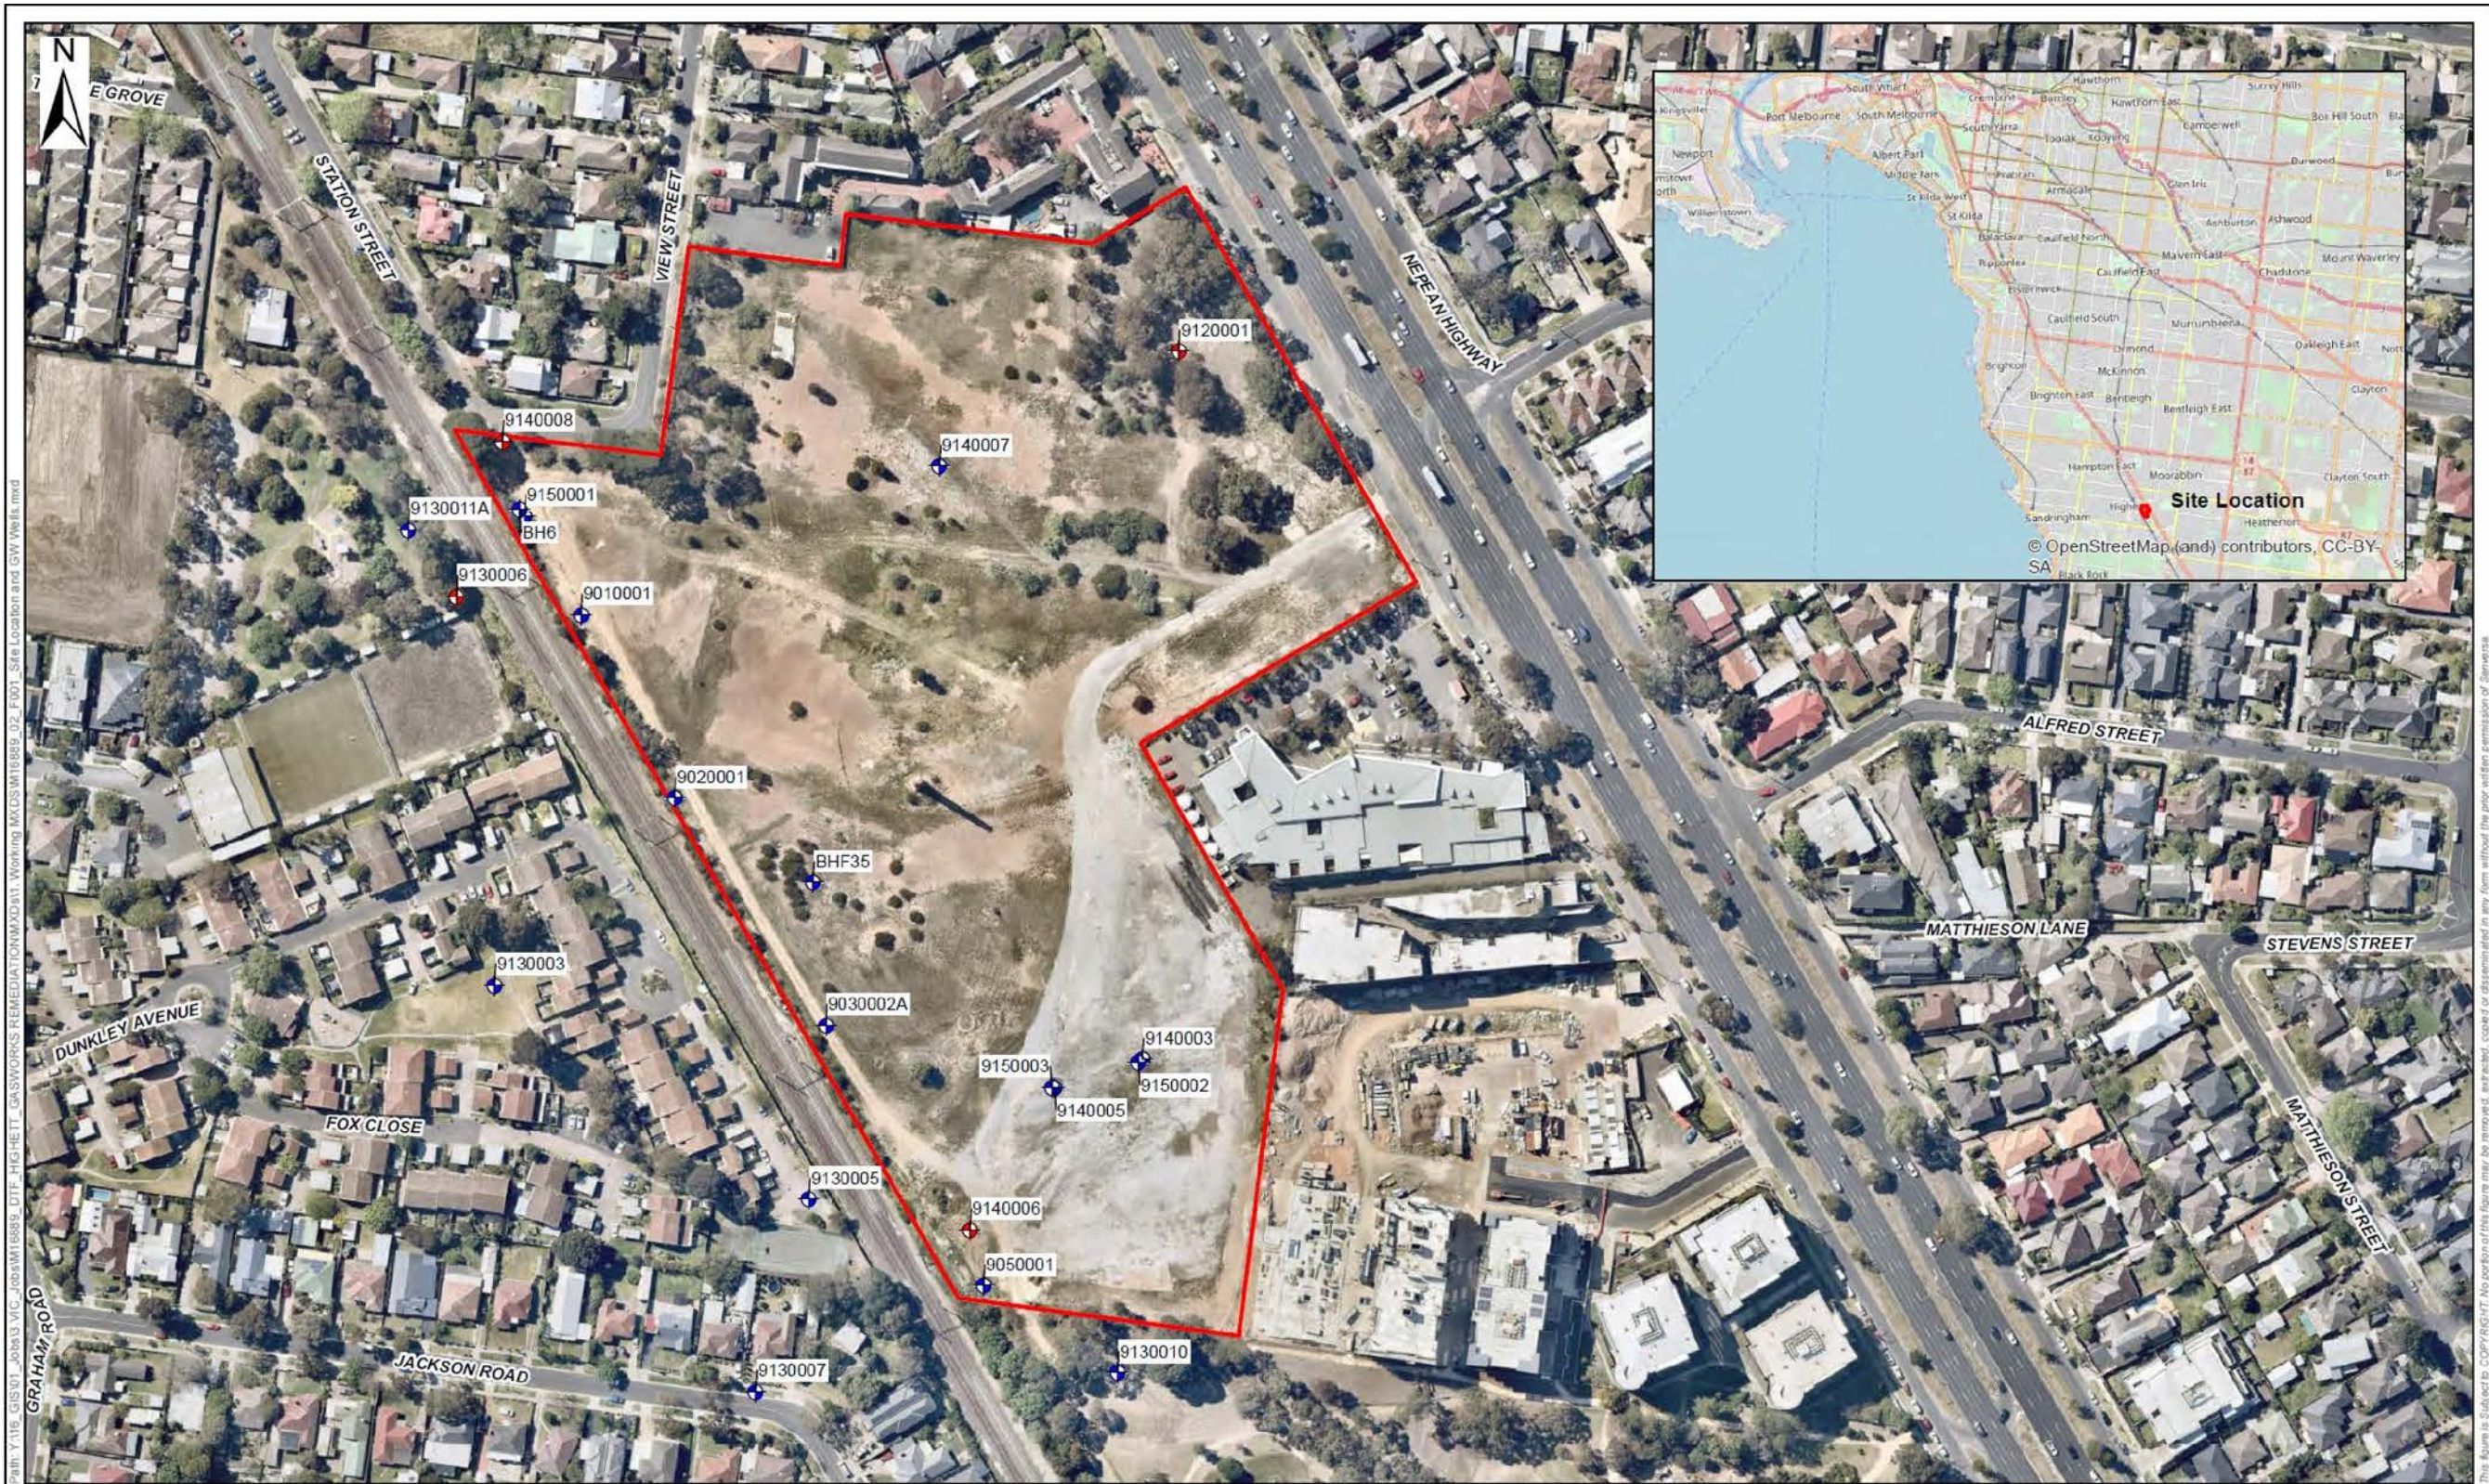
FIGURE 2

*Figure 2      GQRUZ Boundary*
